## Patriot Home Inspections

## Home Inspection Report

123 Any Street

Inspected on Wed, Feb 23 2022 at 6:07 PM

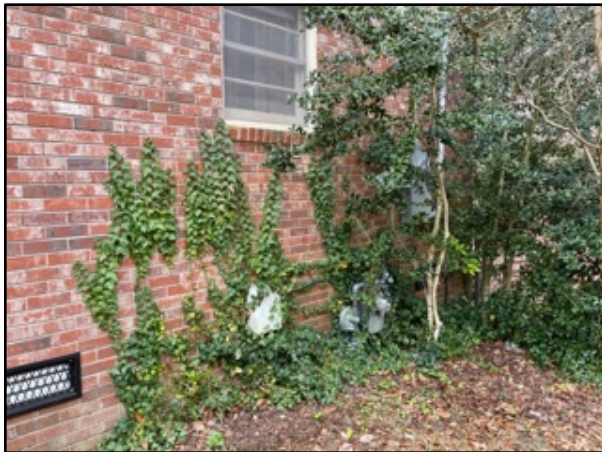
Figure 3-1

1) Comment 3: Vegetation and vines should be trimmed away from the house to avoid damage to the building.

Vegetation and vines should be trimmed away from the house to avoid damage to the building.

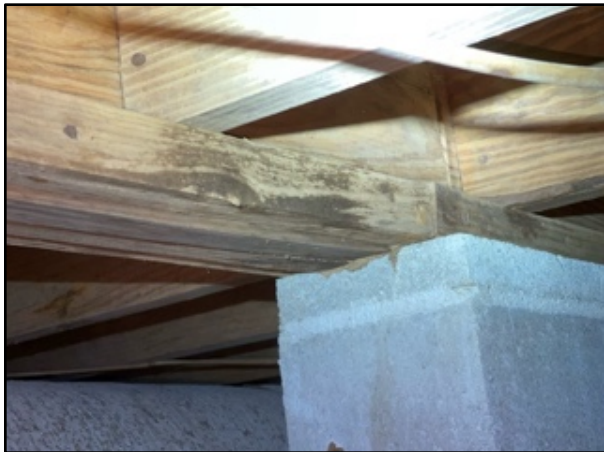
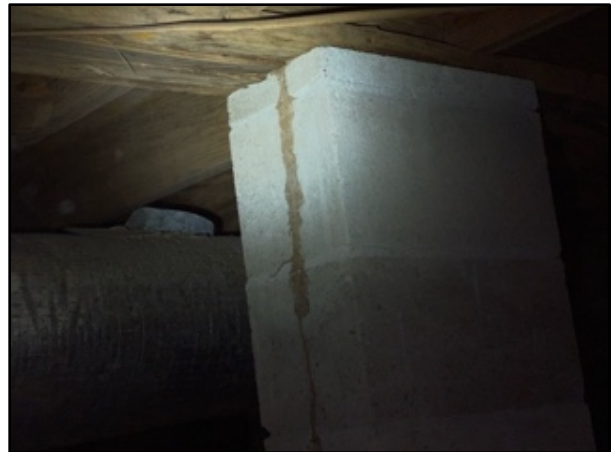
2) Comment 5: This home is in an area known for termite activity. Evidence of prior termite activity was observed. It is recommended that you maintain an active termite bond on the home for the duration of ownership. If no termite bond is in place, preventive treatment may be necessary.

This home is in an area known for termite activity. Evidence of prior termite activity was observed. It is recommended that you maintain an active termite bond on the home for the duration of ownership. If no termite bond is in place, preventive treatment may be necessary.

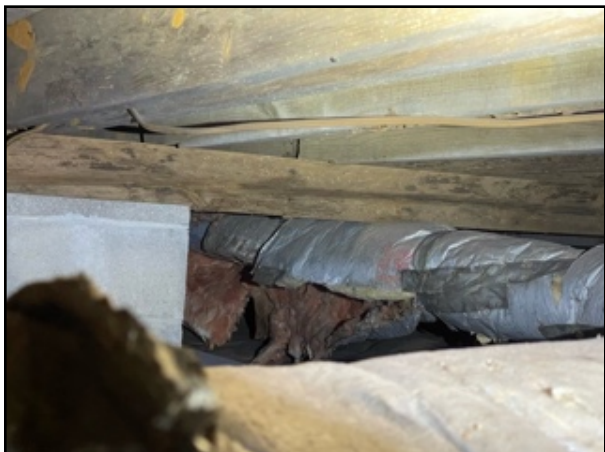
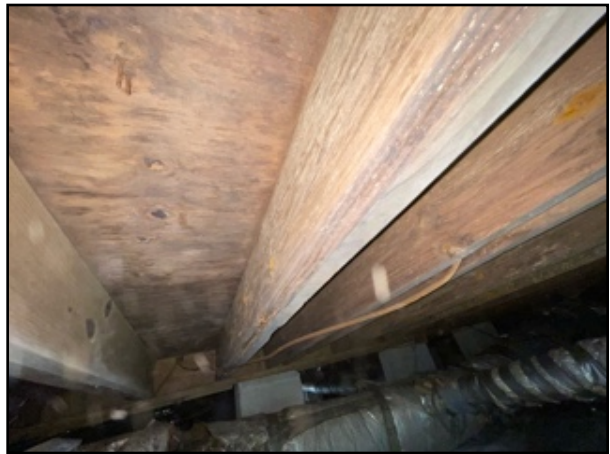
3) Comment 6: There is water staining and dry rot to the front floor joists across the front bedrooms in the crawl space. Inspect and repair is recommended by a licensed contractor.

There is water staining and dry rot to the front floor joists across the front bedrooms in the crawl space. Inspect and repair is recommended by a licensed contractor.

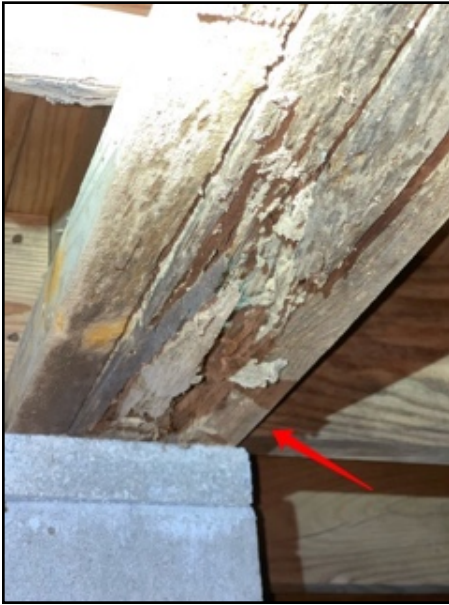
Figure 7-1

4) Comment 7: There is termite damage along the center beam from the hallway to the kitchen area. Inspect and repair is recommended by a licensed contractor.

There is termite damage along the center beam from the hallway to the kitchen area. Inspect and repair is recommended by a licensed contractor.

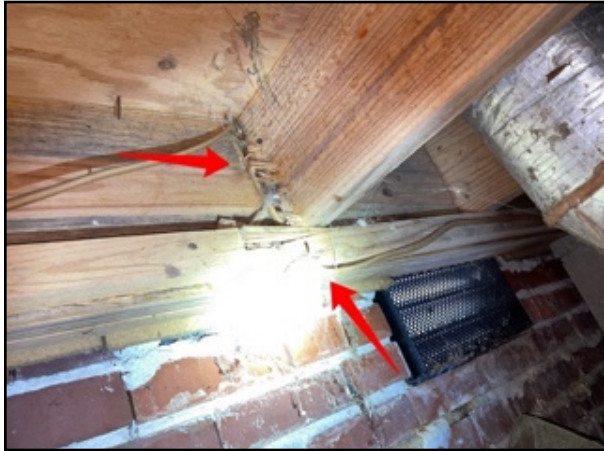
Figure 8-1

5) Comment 8: There is termite damage along the front porch. Inspect and repair is recommended by a licensed contractor.

There is termite damage along the front porch. Inspect and repair is recommended by a licensed contractor.

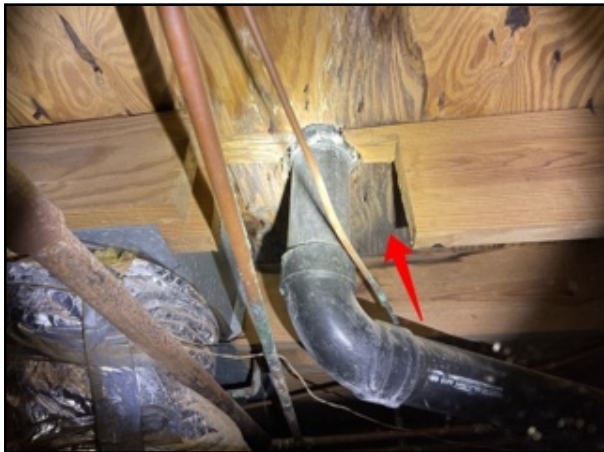
Figure 9-1

6) Comment 9: The floor joist under the toilet drain is cut in two without cross header reinforcement. Repair is recommended by a licensed contractor.

The floor joist under the toilet drain is cut in two without cross header reinforcement. Repair is recommended by a licensed contractor.

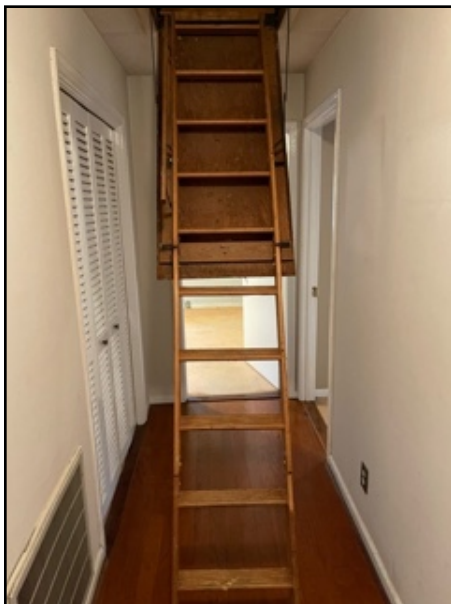
Figure 11-1

7) Comment 11: The attic access ladder is broken. Repair is recommended by a licensed contractor.

The attic access ladder is broken. Repair is recommended by a licensed contractor.

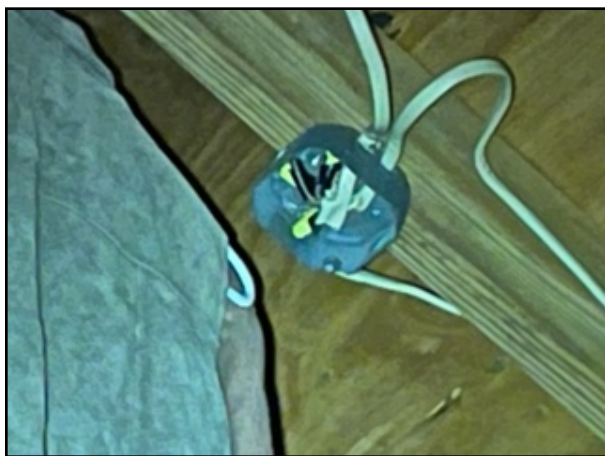
Figure 12-1

8) Comment 12: Open junction boxes were observed in the attic. All wire connections should be made inside an electrical junction box fitted with a cover plate. Repair is recommended by a licensed electrician.

Open junction boxes were observed in the attic. All wire connections should be made inside an electrical junction box fitted with a cover plate. Repair is recommended by a licensed electrician.

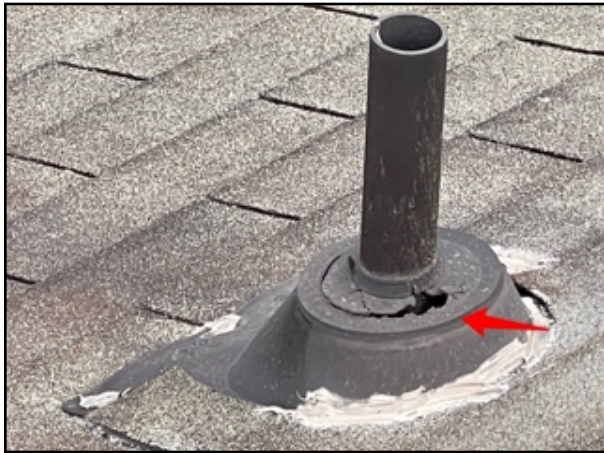
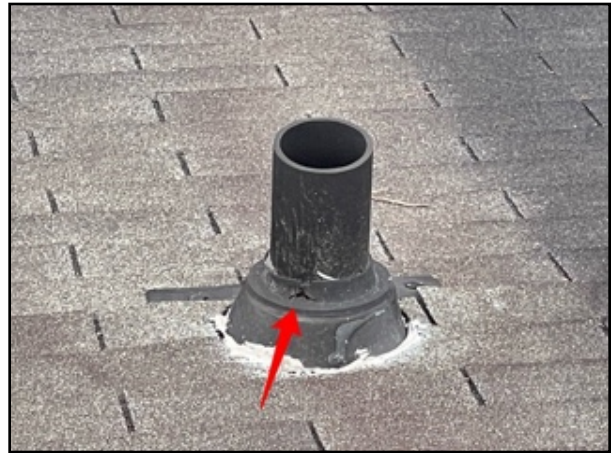
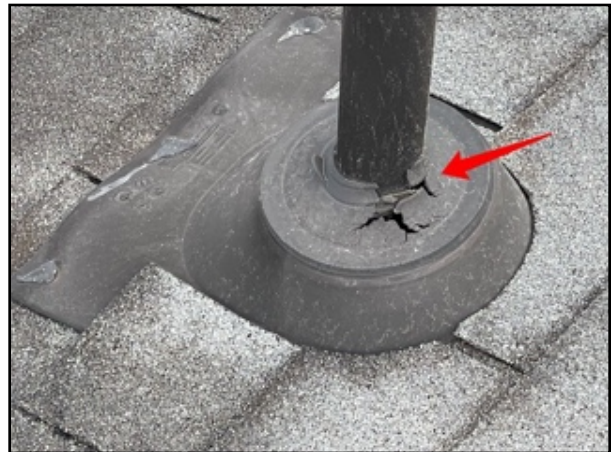
9) Comment 13: The plumbing vent boot flashings have deteriorated. Water staining was observed to the roof decking in the attic. Repair is recommended by a licensed contractor.

The plumbing vent boot flashings have deteriorated. Water staining was observed to the roof decking in the attic Repair is recommended by a licensed contractor.

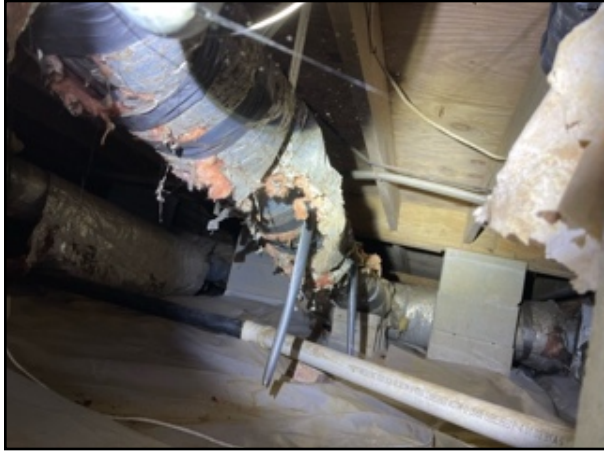
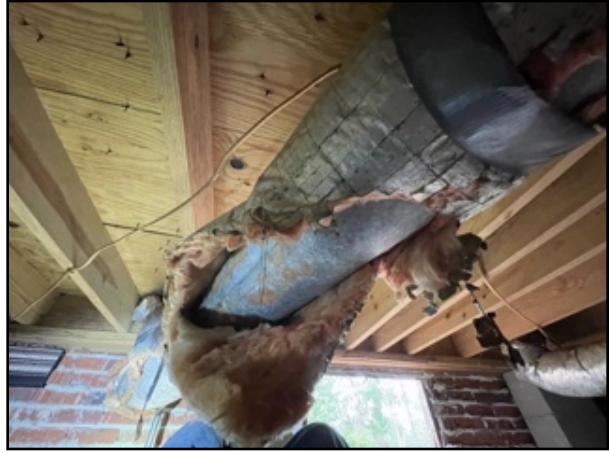
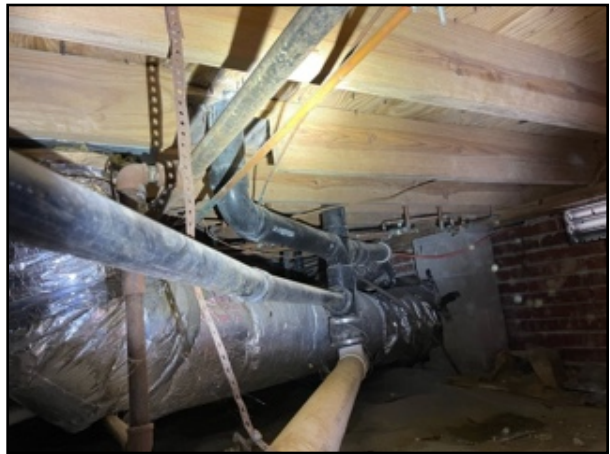
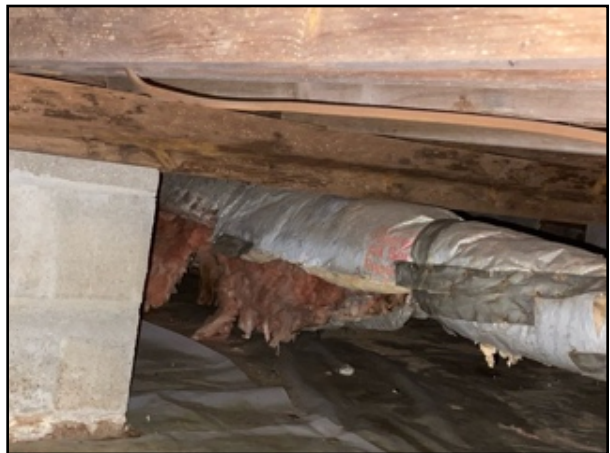
10) Comment 15: There is loose/damaged insulation around the metal ductwork in the crawlspace was observed. Repair is recommended by a licensed contractor.

There is loose/damaged insulation around the metal ductwork in the crawlspace was observed. Repair is recommended by a licensed contractor.

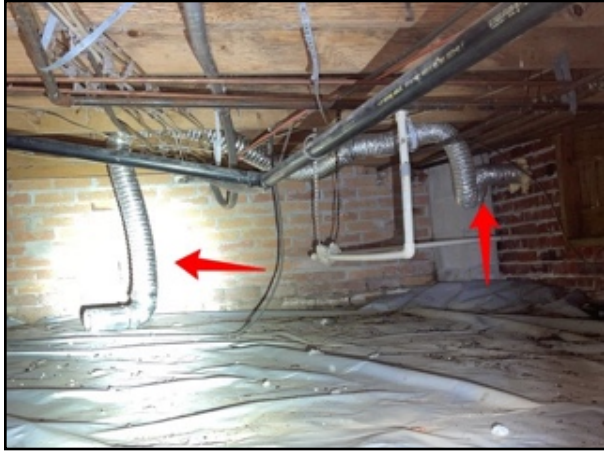
Figure 16-1

11) Comment 16: The clothes dryer vent pipe is improperly installed in the crawlspace. A flex pipe is currently installed from the dryer to the exterior. A rigid 4" metal vent pipe is needed to provide a direct path from the dryer to the exterior of the building. Repair is needed by a licensed contractor.

The clothes dryer vent pipe is improperly installed in the crawlspace. A flex pipe is currently installed from the dryer to the exterior. A rigid 4" metal vent pipe is needed to provide a direct path from the dryer to the exterior of the building. Repair is needed by a licensed contractor.

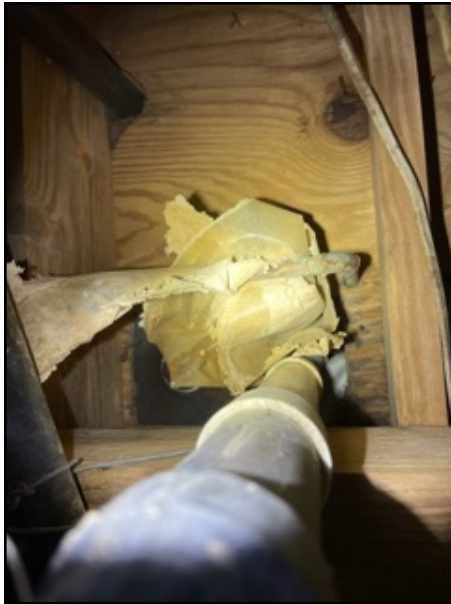
Figure 17-1

12) Comment 17: There is a drip leak at the master bathtub. Repair is recommended by a licensed plumber.

There is a drip leak at the master bathtub. Repair is recommended by a licensed plumber.

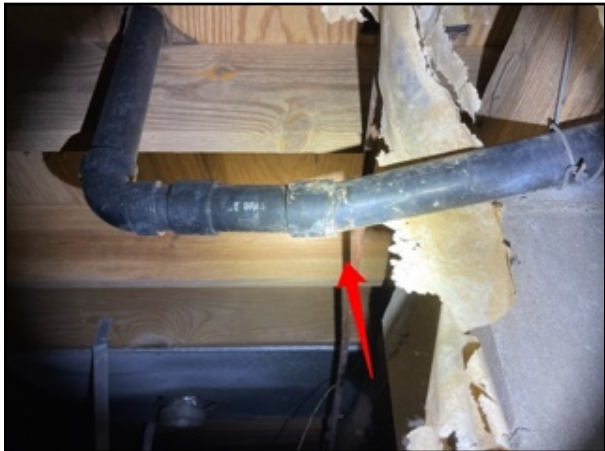
Figure 18-1

13) Comment 18: There is a loose piping joint under the master bathroom in the crawl space. Repair is recommended by a licensed plumber.

There is a loose piping joint under the master bathroom in the crawl space. Repair is recommended by a licensed plumber.

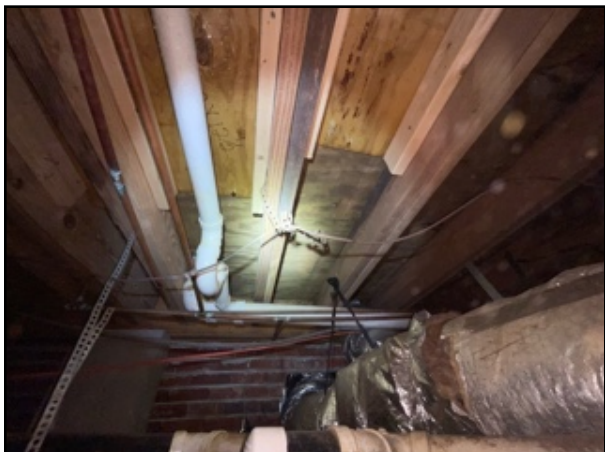
Figure 19-1

14) Comment 19: Prior floor structure repairs were observed underneath the hall bathroom.

Prior floor structure repairs were observed underneath the hall bathroom.

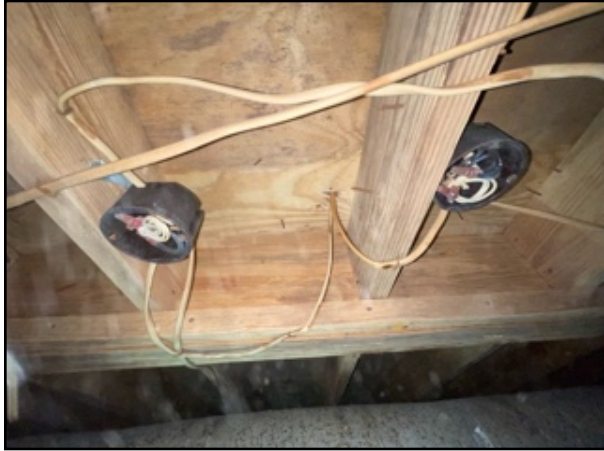
Figure 20-1

15) Comment 20: Open junction boxes were observed in the crawl space near the kitchen area. Electrical connections should be located inside and electrical junction box fitted with a cover plate. Repair is recommended by a licensed electrician.

Open junction boxes were observed in the crawl space near the kitchen area. Electrical connections should be located inside and electrical junction box fitted with a cover plate. Repair is recommended by a licensed electrician.

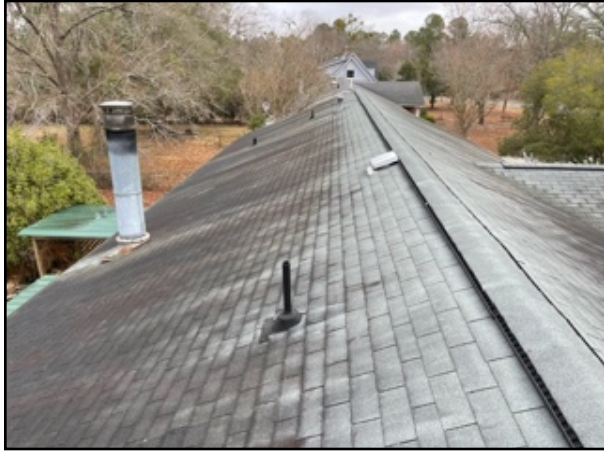
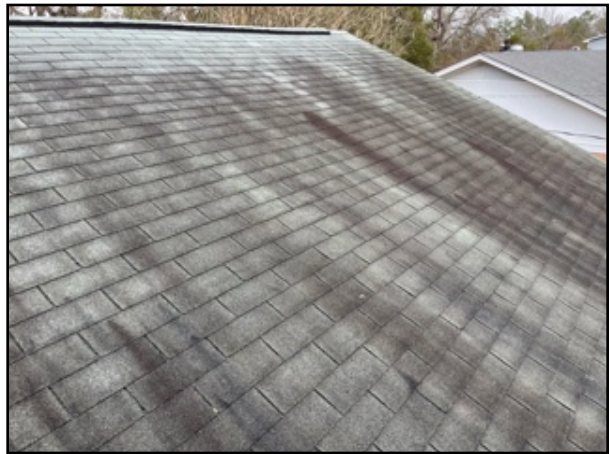
16) Comment 21: The roof coverings are nearing the end of their useful life. The roof age is estimated to be 16-20 years old. Asphalt shingles have an approximate lifespan of approximately 15-20 years, depending on care and weather conditions. You should anticipate replacement in the near future.

The roof coverings are nearing the end of their useful life. The roof age is estimated to be 16-20 years old. Asphalt shingles have an approximate lifespan of approximately 15-20 years, depending on care and weather conditions. You should anticipate replacement in the near future.

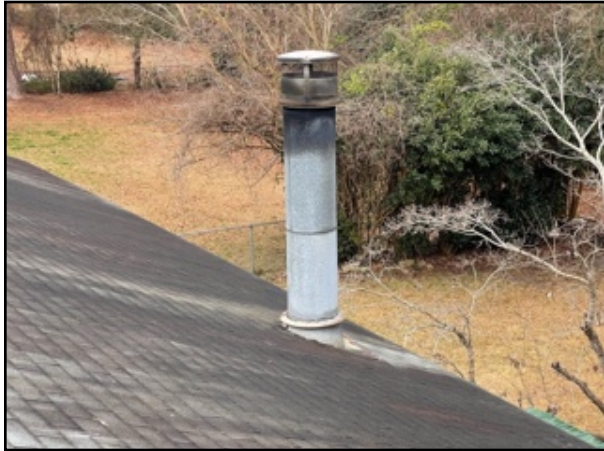
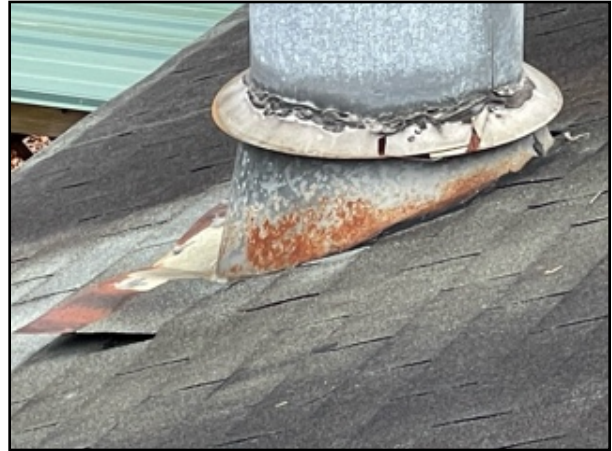
17) Comment 22: The flashing around the metal chimney flue is lifted. Repair is recommended by a licensed contractor.

The flashing around the metal chimney flue is lifted. Repair is recommended by a licensed contractor.

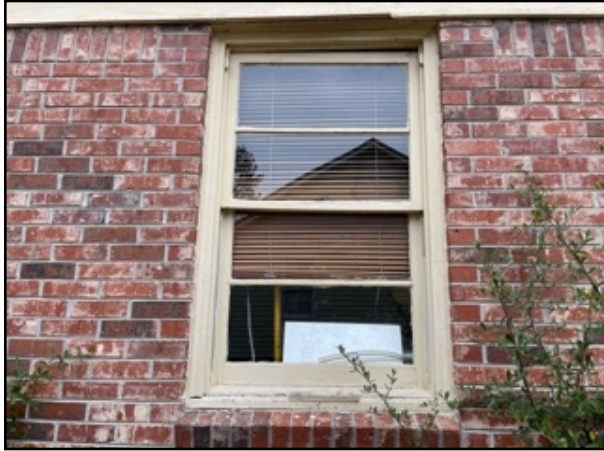
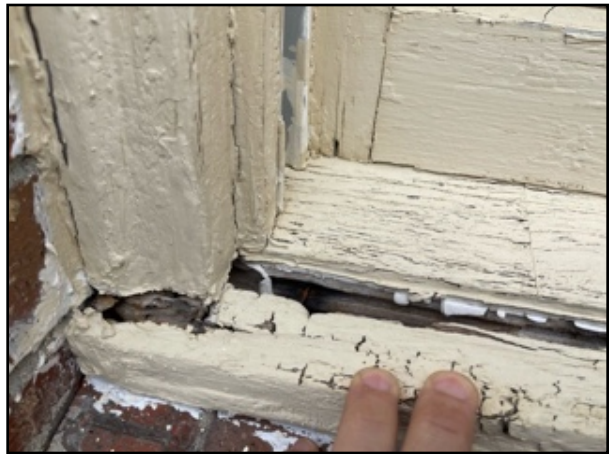
18) Comment 24: There is wood rot in the side window frame. Repair is recommended by a licensed contractor.

There is wood rot in the side window frame. Repair is recommended by a licensed contractor.

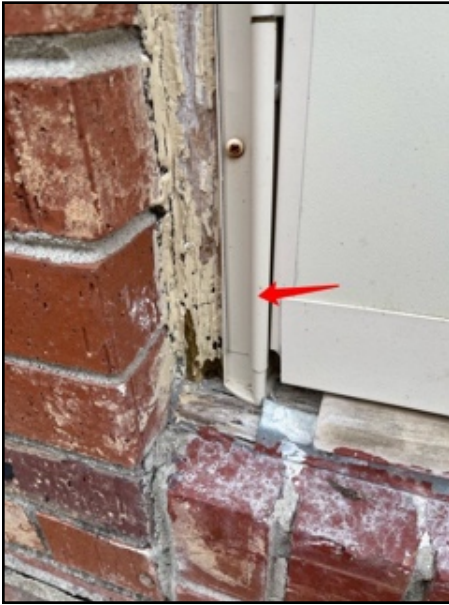
Figure 25-1

19) Comment 25: There is wood rot in the rear door trim. Repair is recommended by a licensed contractor.

**Comment 25:**  
There is wood rot in the rear door trim. Repair is recommended by a licensed contractor.

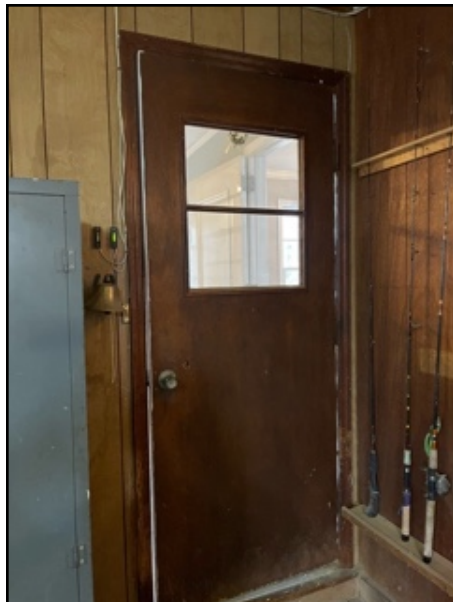
Figure 29-1

23) Comment 29: The entry door from the house to the garage is not fire rated. Entry doors to the garage require a 20 minute fire rating per standard building practices. Repair is needed by a licensed contractor.

The entry door from the house to the garage is not fire rated. Entry doors to the garage require a 20 minute fire rating per standard building practices. Repair is needed by a licensed contractor.

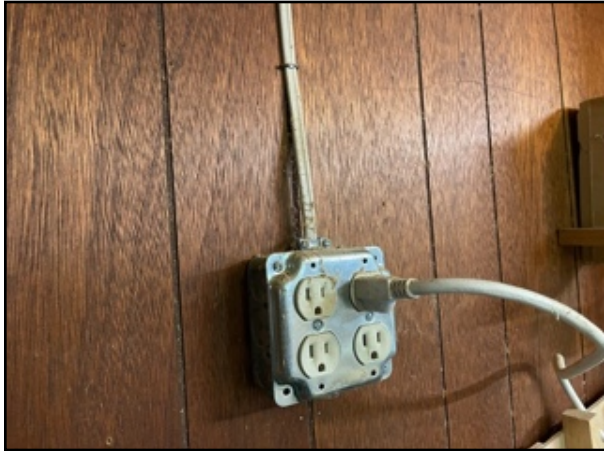
Figure 30-1

24) Comment 30: Wiring on the interior of the garage is exposed. Wiring should be covered or protected by electrical conduit. Repair is recommended by a licensed electrician.

Wiring on the interior of the garage is exposed. Wiring should be covered or protected by electrical conduit. Repair is recommended by a licensed electrician.

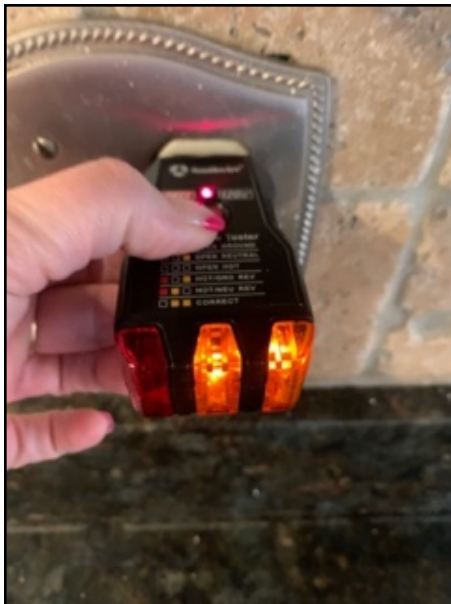
Figure 34-1

25) Comment 34: There are no ground fault circuit interrupter (GFCI) protection at the kitchen outlets. Since GFCI provides protection from electrocution in areas where electricity can come in contact with water, it is recommended that GFCI outlets be installed in wet areas. Repair is recommended by a licensed electrician.

There are no ground fault circuit interrupter (GFCI) protection at the kitchen outlets. Since GFCI provides protection from electrocution in areas where electricity can come in contact with water, it is recommended that GFCI outlets be installed in wet areas. Repair is recommended by a licensed electrician.

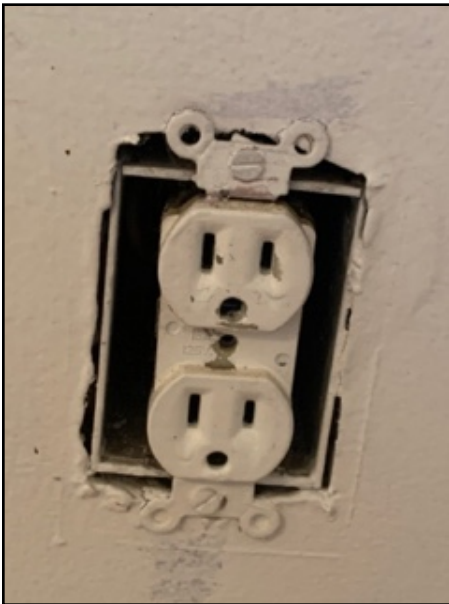
Figure 35-1

26) Comment 35: Missing electrical outlet cover faceplate should be replaced.

Missing electrical outlet cover faceplate should be replaced.

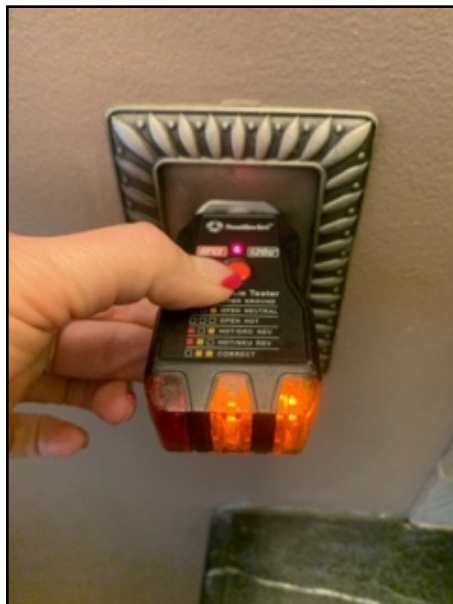
Figure 36-1

27) Comment 36: There are no ground fault circuit interrupter (GFCI) protection at the hall bathroom outlet. Since GFCI provides protection from electrocution in areas where electricity can come in contact with water, it is recommended that GFCI outlets be installed in wet areas. Repair is recommended by a licensed electrician.

There are no ground fault circuit interrupter (GFCI) protection at the hall bathroom outlet. Since GFCI provides protection from electrocution in areas where electricity can come in contact with water, it is recommended that GFCI outlets be installed in wet areas. Repair is recommended by a licensed electrician.

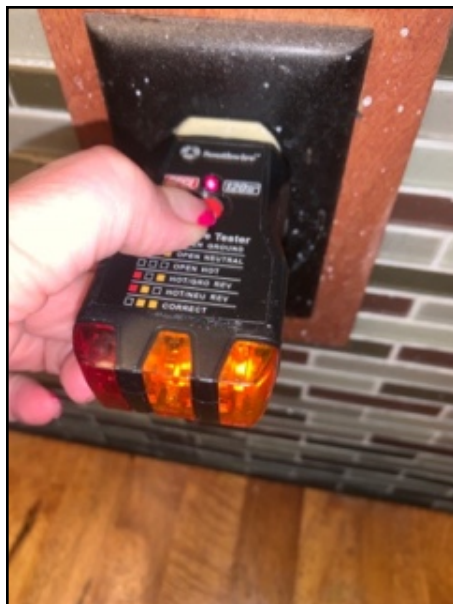
Figure 37-1

28) Comment 37: There are no ground fault circuit interrupter (GFCI) protection at the master bathroom outlet. Since GFCI provides protection from electrocution in areas where electricity can come in contact with water, it is recommended that GFCI outlets be installed in wet areas. Repair is recommended by a licensed electrician.

There are no ground fault circuit interrupter (GFCI) protection at the master bathroom outlet. Since GFCI provides protection from electrocution in areas where electricity can come in contact with water, it is recommended that GFCI outlets be installed in wet areas. Repair is recommended by a licensed electrician.

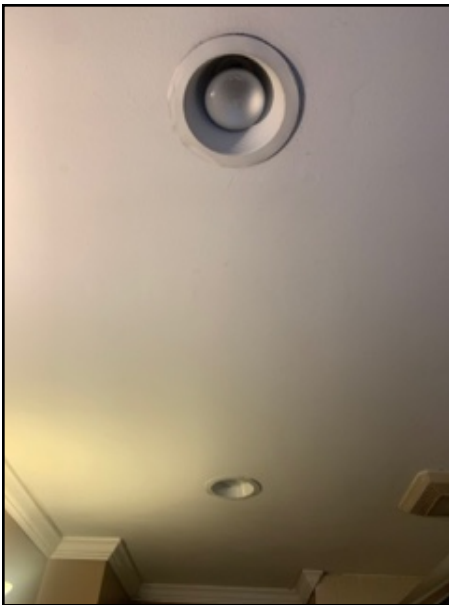
Figure 39-1

30) Comment 39: The overhead recessed lights in the hall bathroom are inoperative. The bulbs may be blown. If the bulbs are not blown, the circuit will need to be examined by a licensed electrician for repair.

The overhead recessed lights in the hall bathroom are inoperative. The bulbs may be blown. If the bulbs are not blown, the circuit will need to be examined by a licensed electrician for repair.

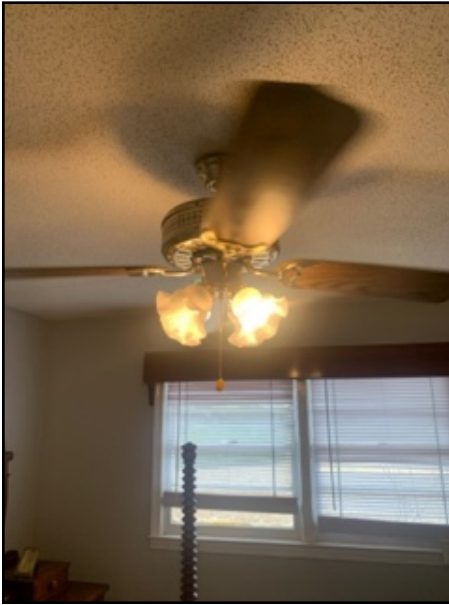
Figure 40-1

31) Comment 40: The light/ ceiling fan in the front bedroom is direct wired and not operated by the light switch. Repair is recommended by a licensed electrician.

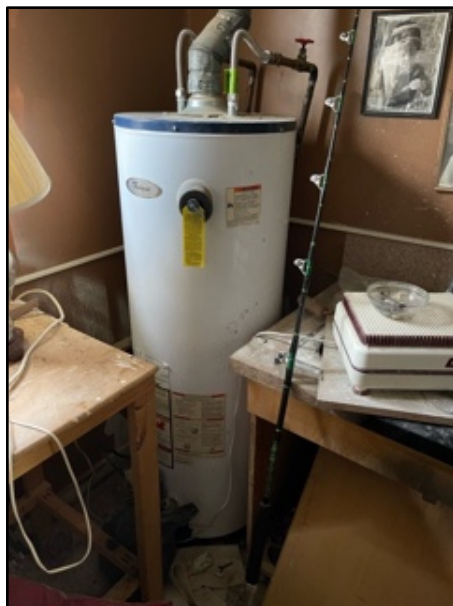
Figure 46-1

The water heater was manufactured in 2013. The typical lifespan of a water heater is 10 to 15 years. The unit responded properly when tested. The system may require a higher level of maintenance or replacement in the near future. No one can predict when replacement will become necessary.

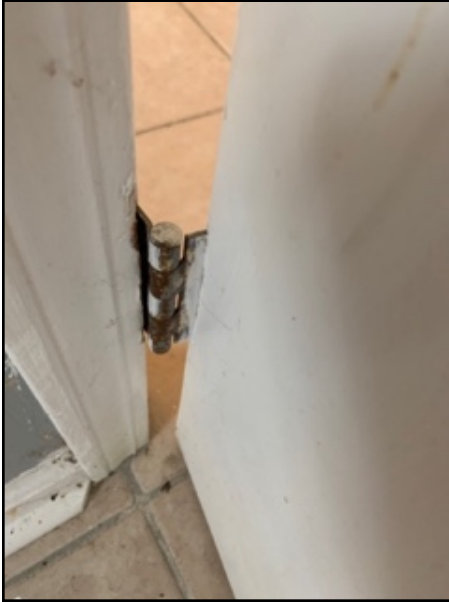
Figure 53-1

35) Comment 53: Loose door hinges on the laundry room door. Repair is recommended by a licensed contractor.

Loose door hinges on the laundry room door. Repair is recommended by a licensed contractor.

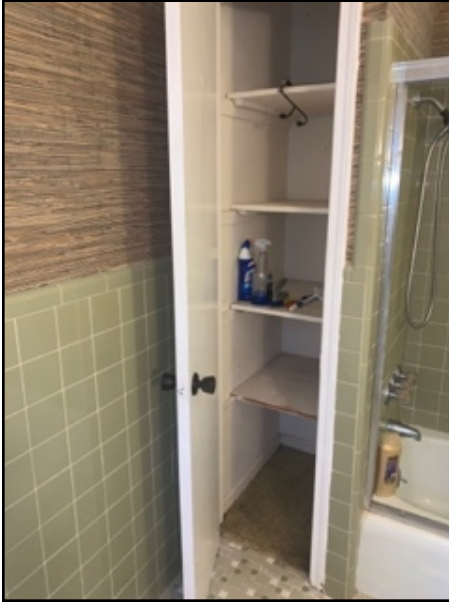
Figure 54-1

36) Comment 54: The master bathroom closet door does not close. The door hinges have been painted. Repair is recommended by a licensed contractor.

The master bathroom closet door does not close. The door hinges have been painted. Repair is recommended by a licensed contractor.

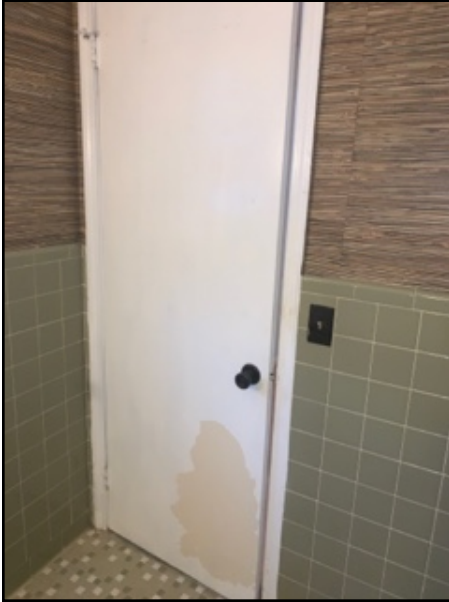
Figure 55-1

37) Comment 55: The master bathroom door does not close. Repair is recommended by a licensed contractor.

The master bathroom door does not close. Repair is recommended by a licensed contractor.

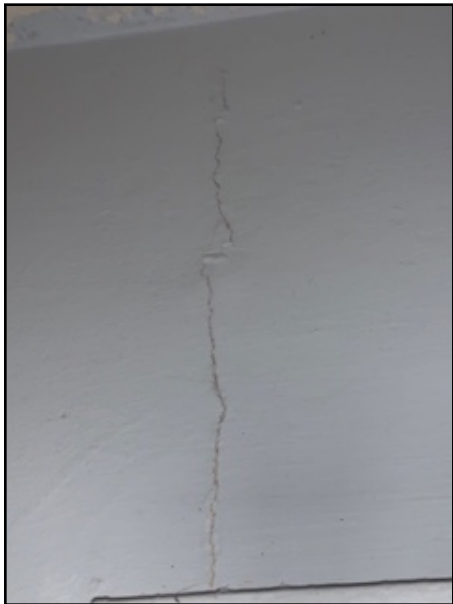
Figure 56-1

38) Comment 56: Cracking observed over the master bathroom doorway. Inspect and repair is recommended by a licensed contractor.

**Comment 56:**  
Cracking observed over the master bathroom doorway. Inspect and repair is recommended by a licensed contractor.

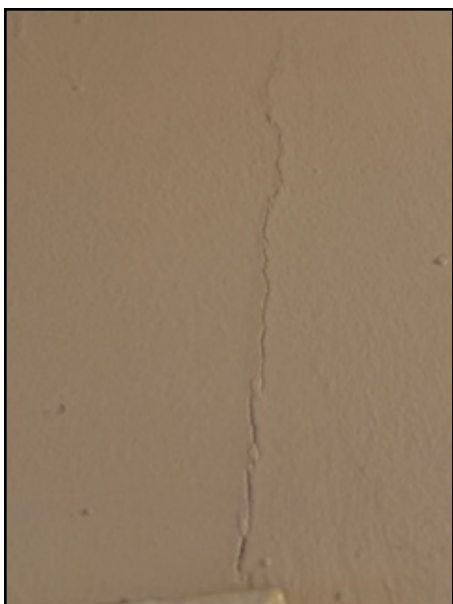
Figure 57-1

39) Comment 57: Settlement cracking observed over the second bedroom door. Inspect and repair is recommended by a licensed contractor.

**Comment 57:**  
Settlement cracking observed over the second bedroom door. Inspect and repair is recommended by a licensed contractor.

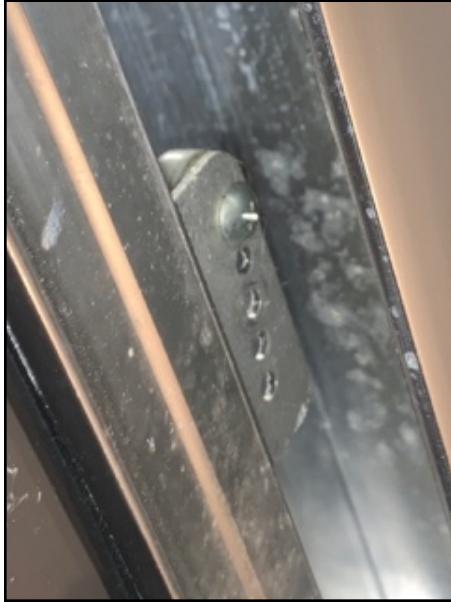
Figure 62-1

40) Comment 62: One of the shower doors is off the track. Repair is recommended by a licensed contractor.

One of the shower doors is off the track. Repair is recommended by a licensed contractor.

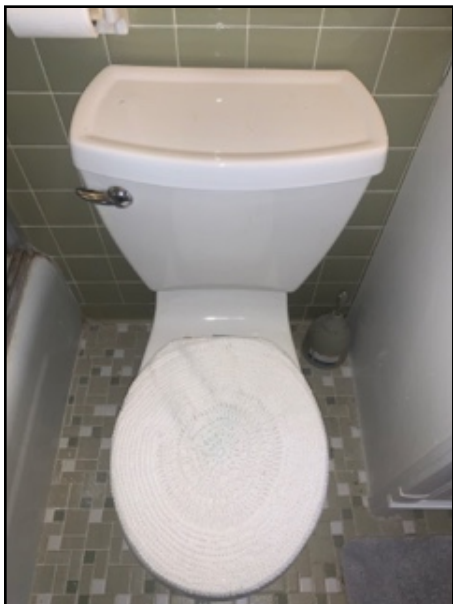
Figure 66-1

41) Comment 66: The toilet is loose at floor. The toilet seal needs to be replaced and firmly secured to the floor. Caulking the base is recommended. Repair is recommended by a licensed plumber.

The toilet is loose at floor. The toilet seal needs to be replaced and firmly secured to the floor. Caulking the base is recommended. Repair is recommended by a licensed plumber.

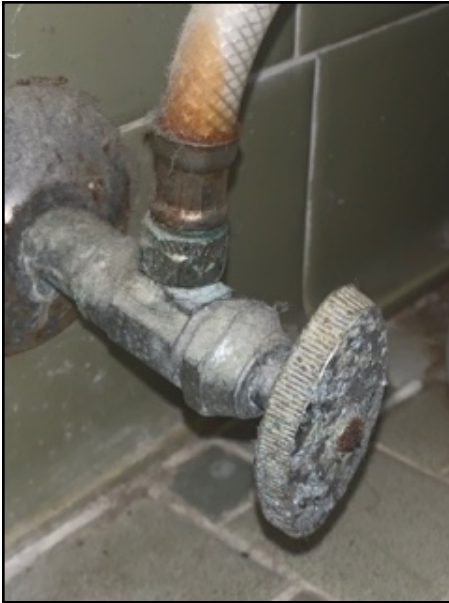
Figure 68-1

43) Comment 68: The toilet tank water shutoff valve is seized. Repair is recommended by a licensed plumber.

The toilet tank water shutoff valve is seized. Repair is recommended by a licensed plumber.
