## Patriot Home Inspections

## Home Inspection Report

123 Any Street

Inspected on Wed, Feb 23 2022 at 6:07 PM

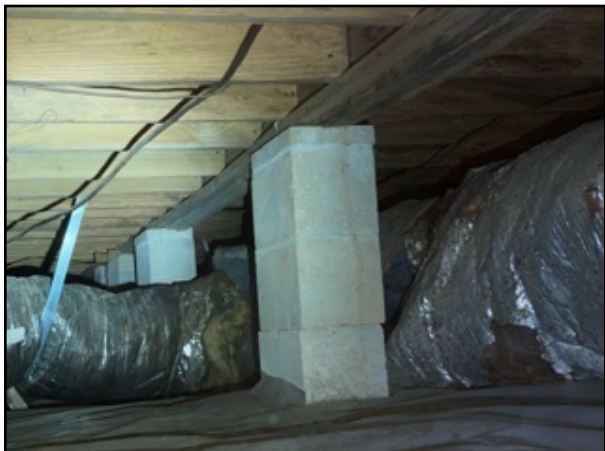
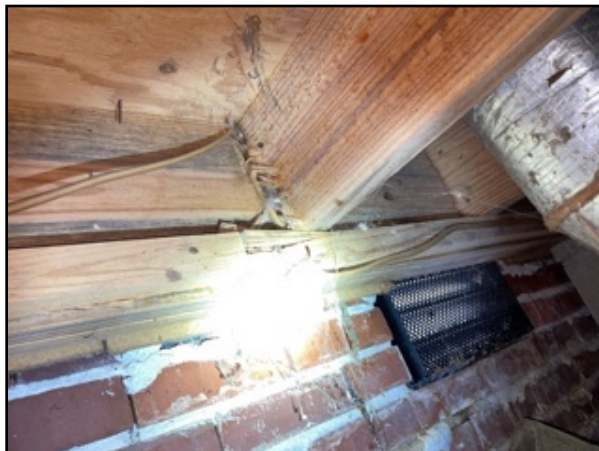
4) Comment 7: There is termite damage along the center beam from the hallway to the kitchen area. Inspect and repair is recommended by a licensed contractor.

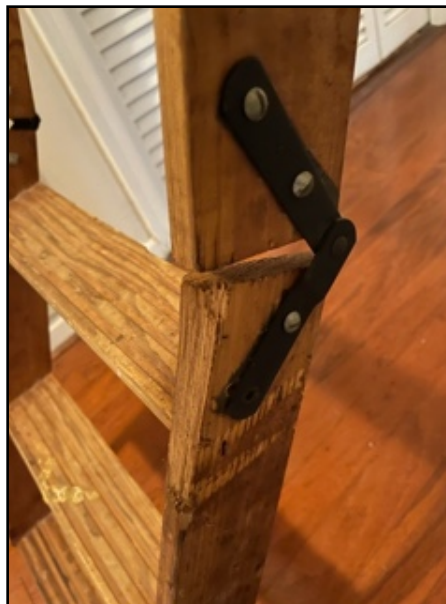
Figure 11-2

7) Comment 11: The attic access ladder is broken. Repair is recommended by a licensed contractor.

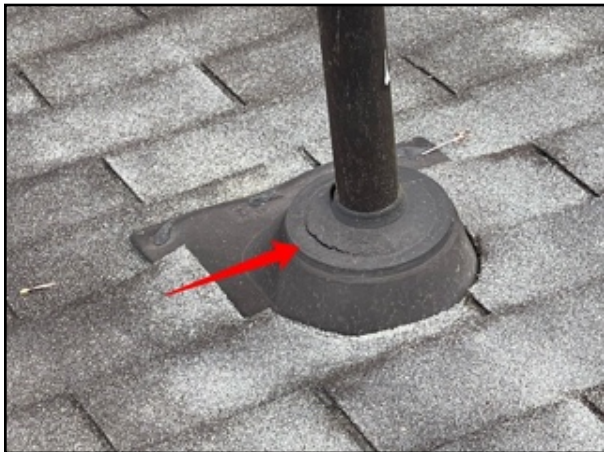
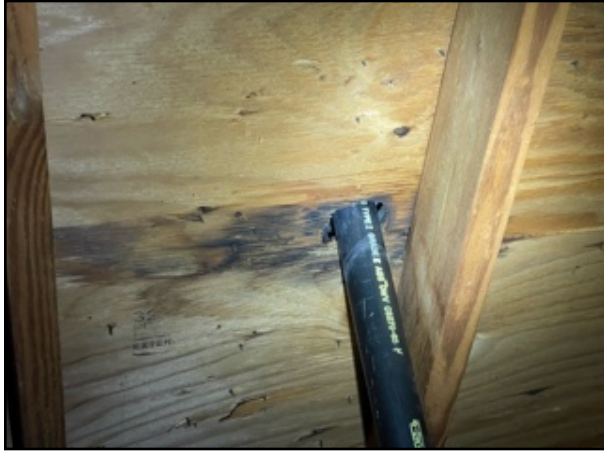
9) Comment 13: The plumbing vent boot flashings have deteriorated. Water staining was observed to the roof decking in the attic. Repair is recommended by a licensed contractor.

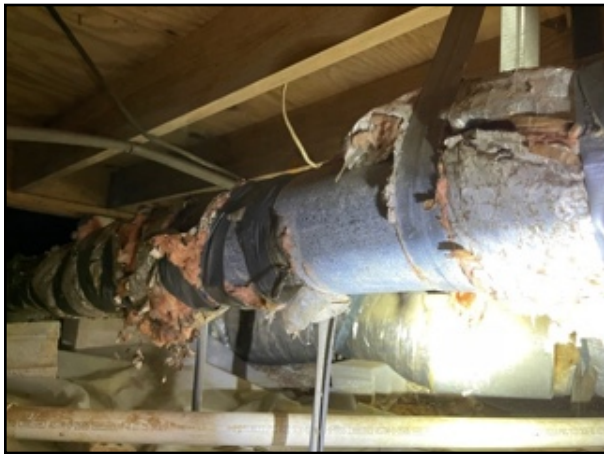
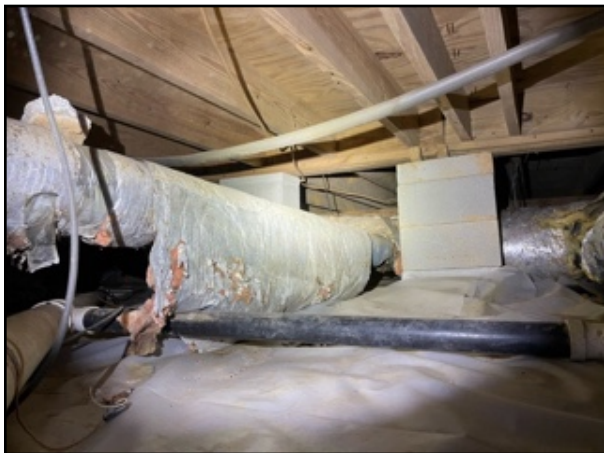
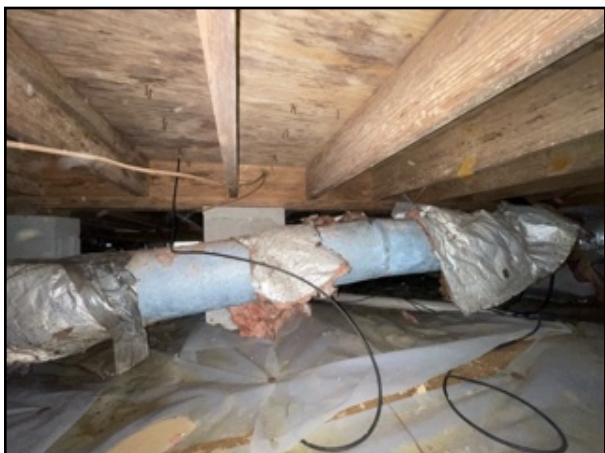
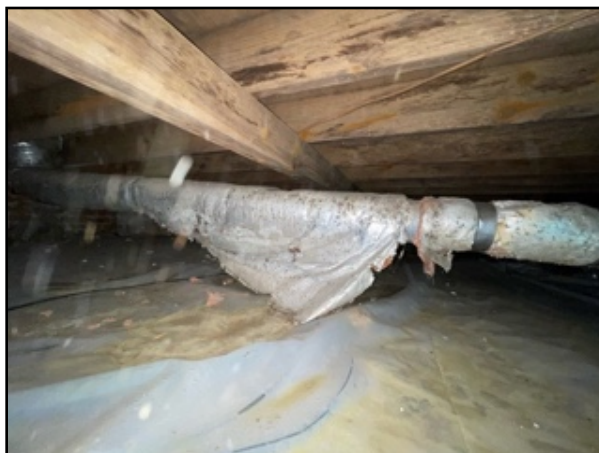
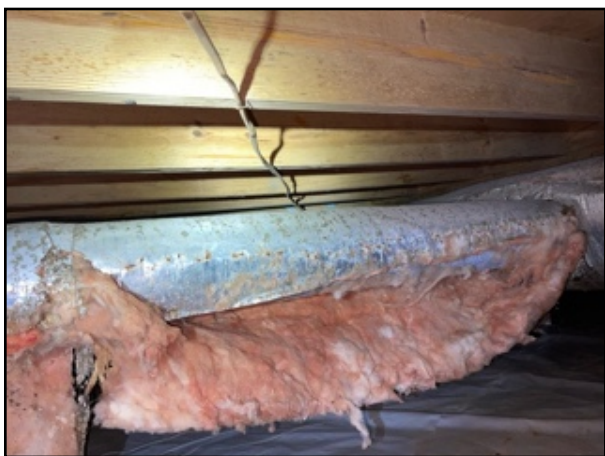
10) Comment 15: There is loose/damaged insulation around the metal ductwork in the crawlspace was observed. Repair is recommended by a licensed contractor.

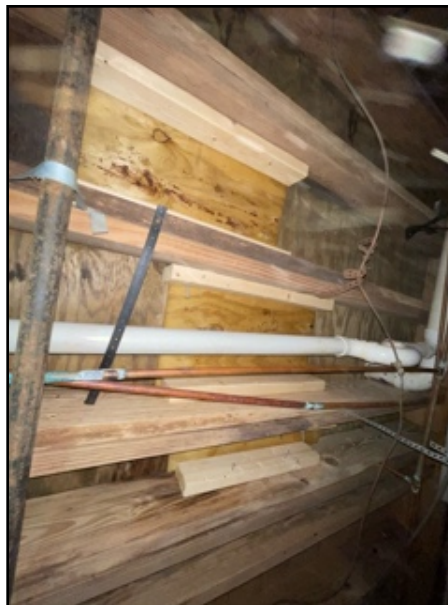
Figure 19-2

14) Comment 19: Prior floor structure repairs were observed underneath the hall bathroom.

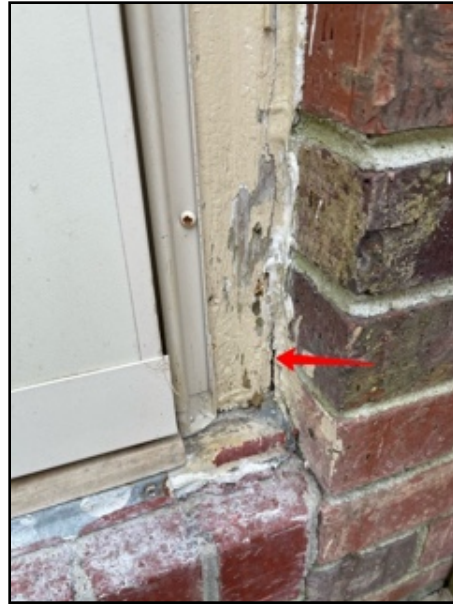
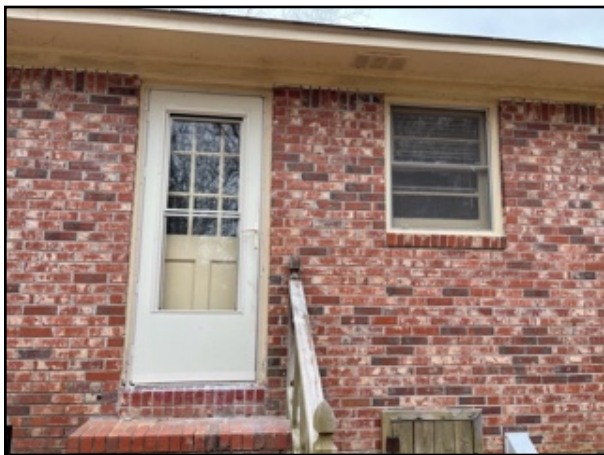
**Comment 25:**  
There is wood rot in the rear door trim. Repair is recommended by a licensed contractor.

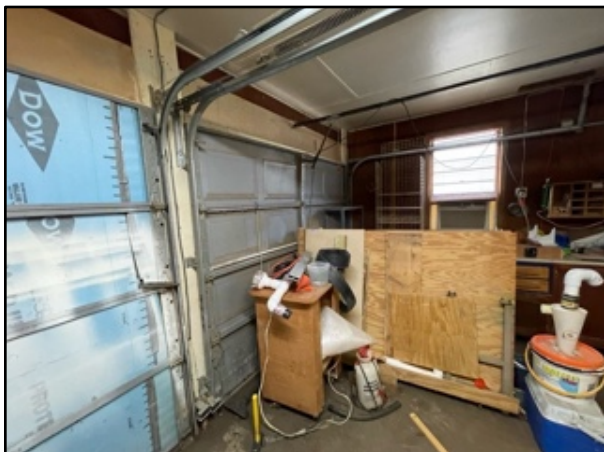
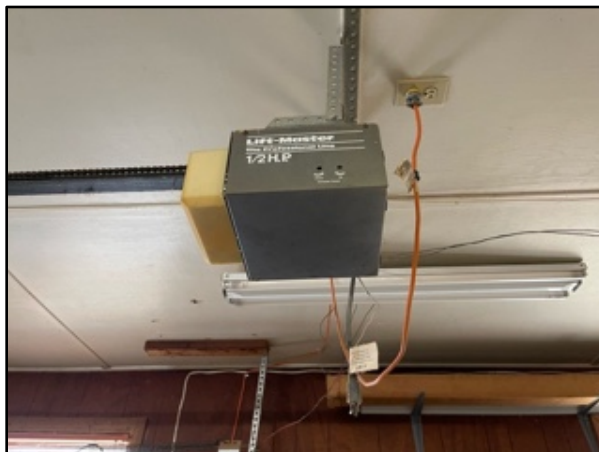
Comment 27:

The right side garage door opener was unplugged. The door does not appear to be used. There is storage in front of the door.

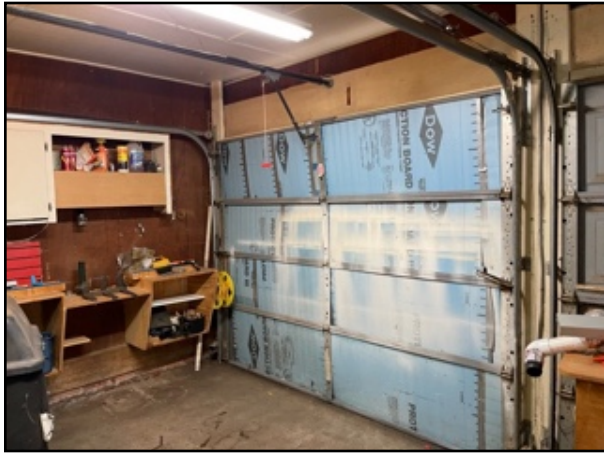
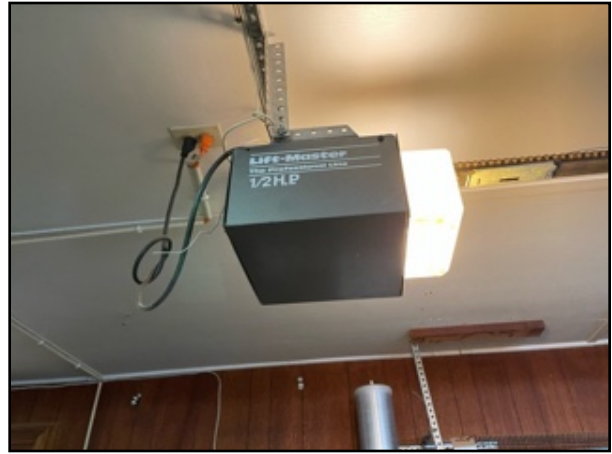
**Comment 28:**

The left garage door was disengaged. The garage door was locked with vice grips.

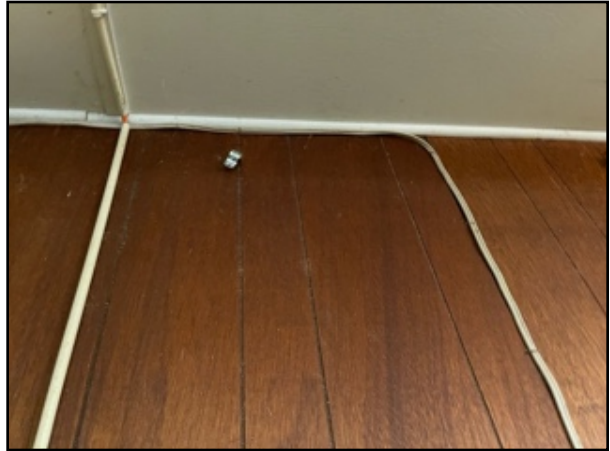
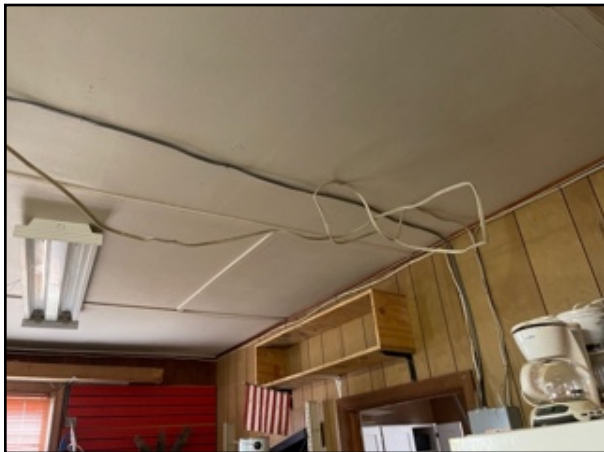
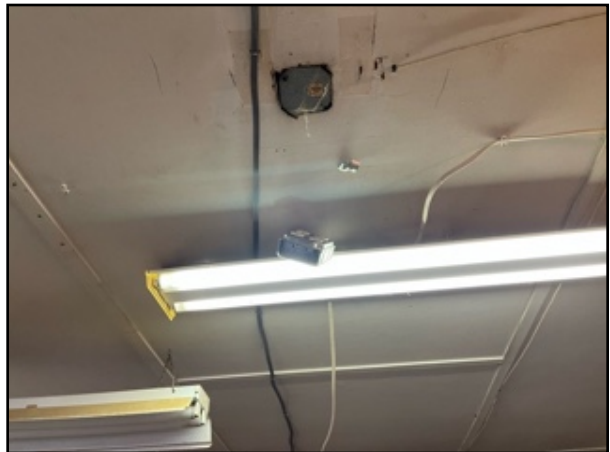
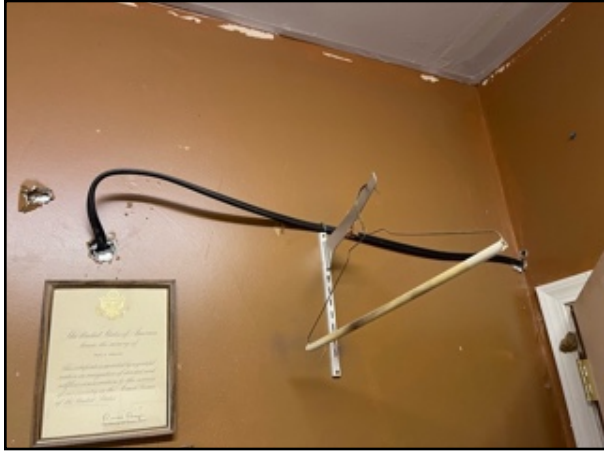
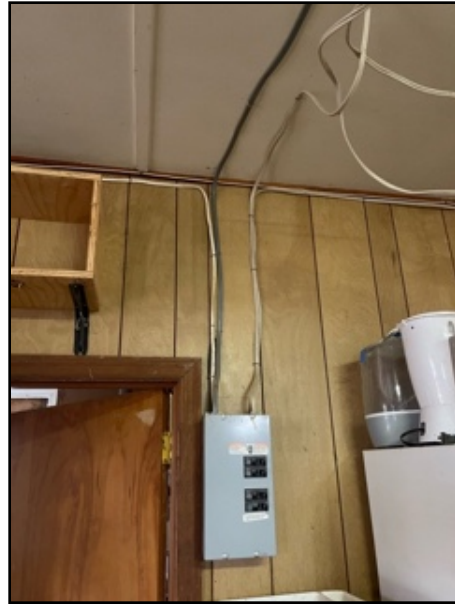
Wiring on the interior of the garage is exposed. Wiring should be covered or protected by electrical conduit. Repair is recommended by a licensed electrician.

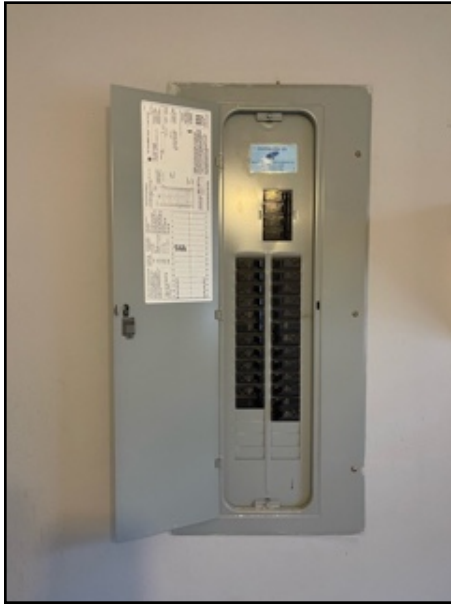
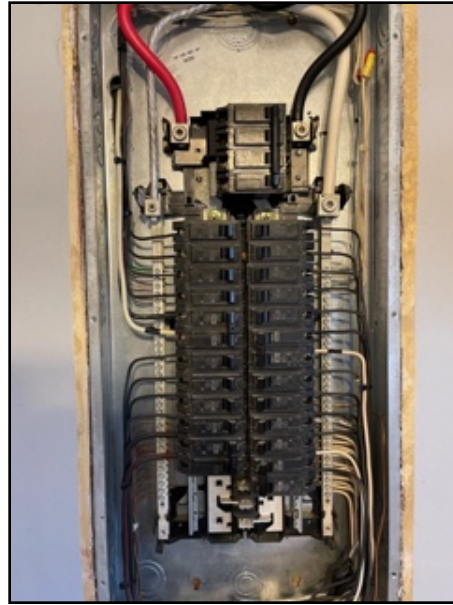
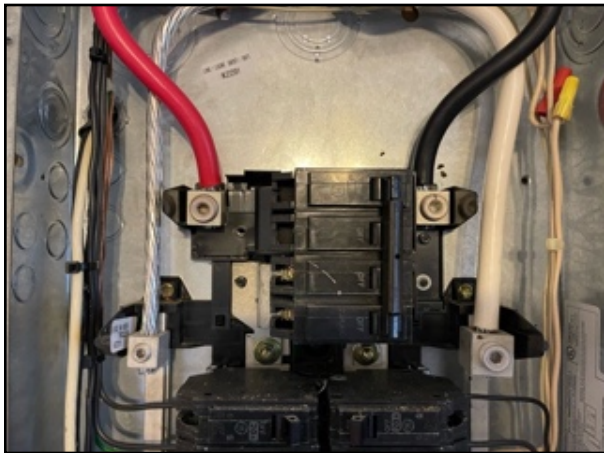
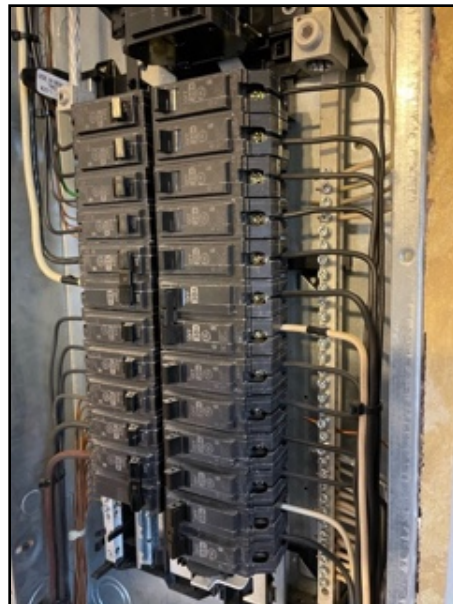
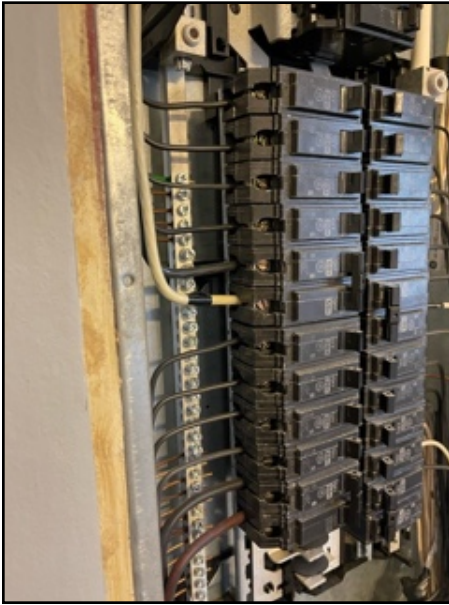
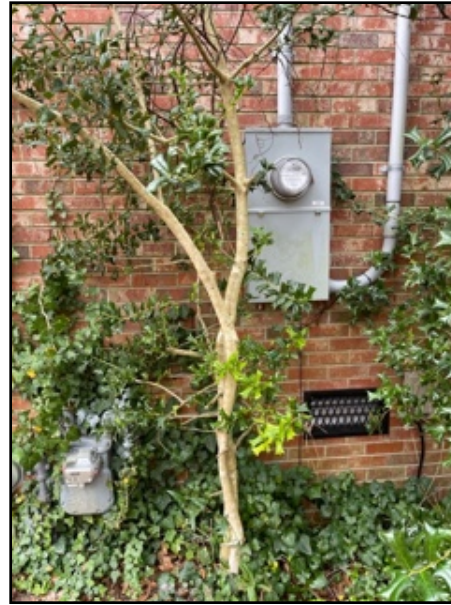
At the time of inspection, the main electrical service was found to be sufficient for a home of the size and type. All breakers are appropriately sized and responded properly when tested.

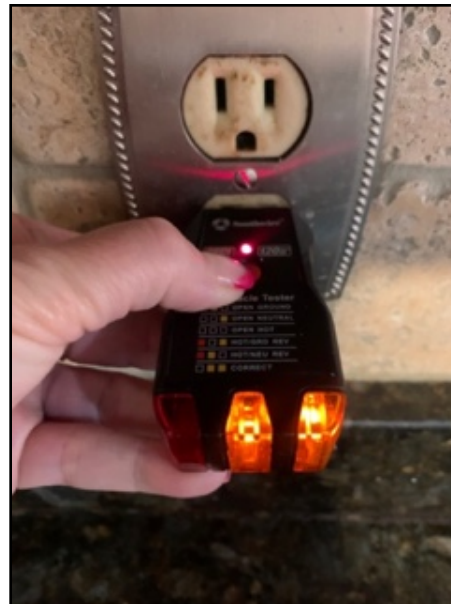
Figure 34-2

There are no ground fault circuit interrupter (GFCI) protection at the kitchen outlets. Since GFCI provides protection from electrocution in areas where electricity can come in contact with water, it is recommended that GFCI outlets be installed in wet areas. Repair is recommended by a licensed electrician.

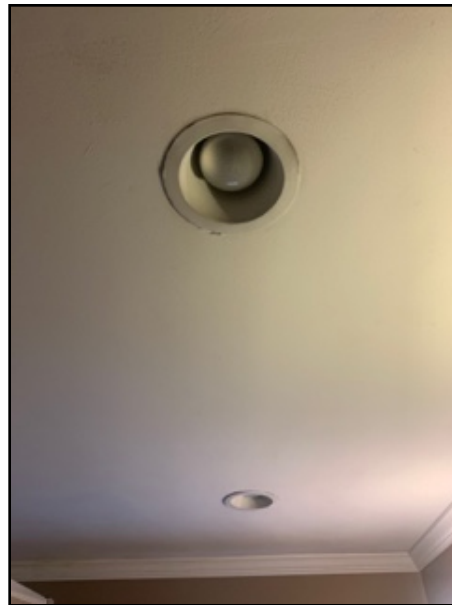
Figure 39-2

The overhead recessed lights in the hall bathroom are inoperative. The bulbs may be blown. If the bulbs are not blown, the circuit will need to be examined by a licensed electrician for repair.

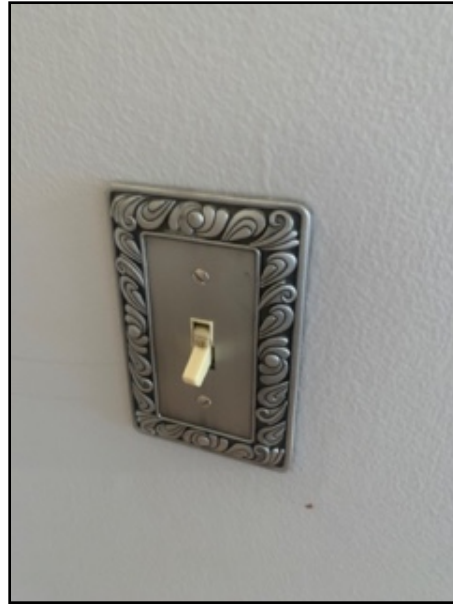
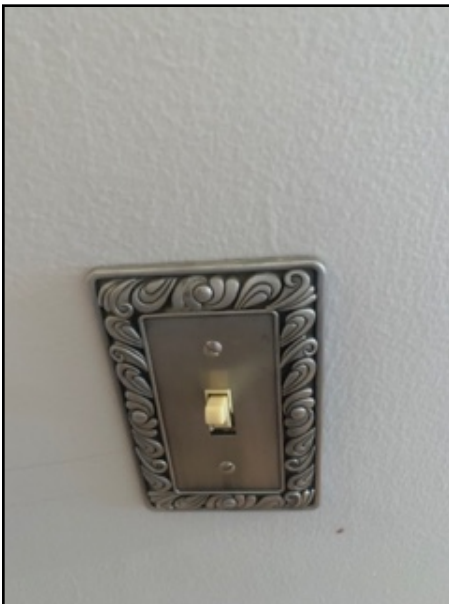
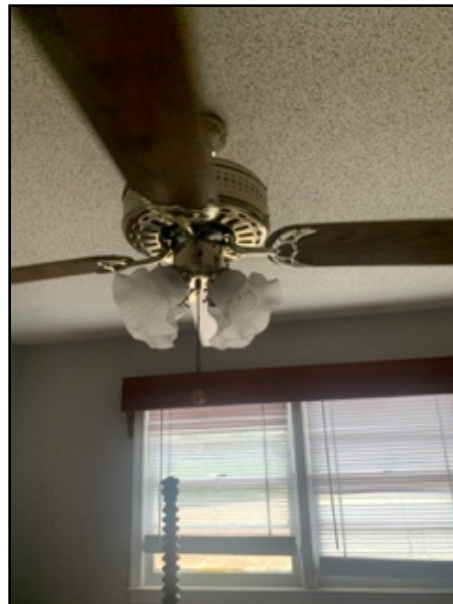
The light/ ceiling fan in the front bedroom is direct wired and not operated by the light switch. Repair is recommended by a licensed electrician.

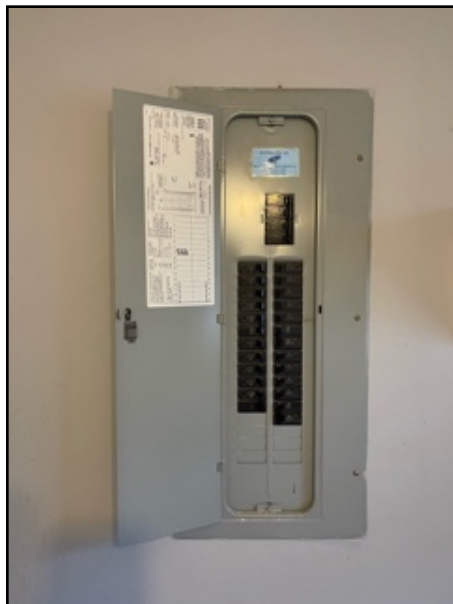
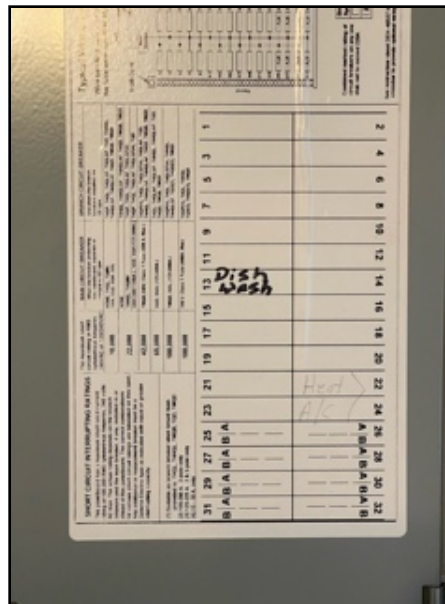
**Comment 41:**

The breakers in the service panel box are not labeled. Identification of the breakers is needed.

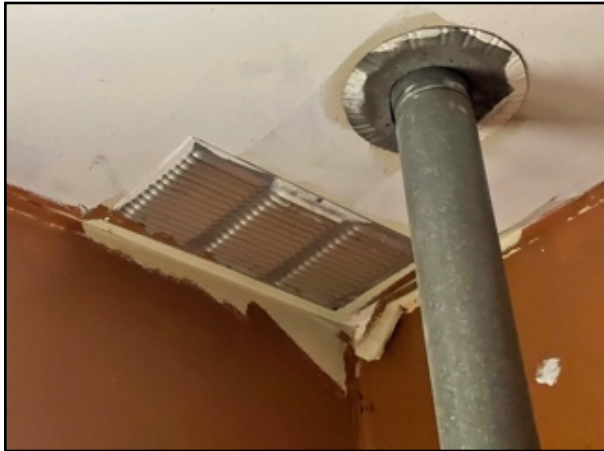
Figure 47-1

Comment 47:

The gas vent flue is entering the attic near an air duct. This is a safety concern.

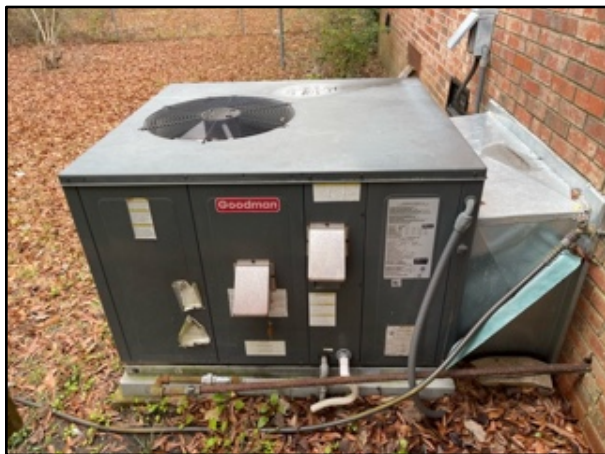
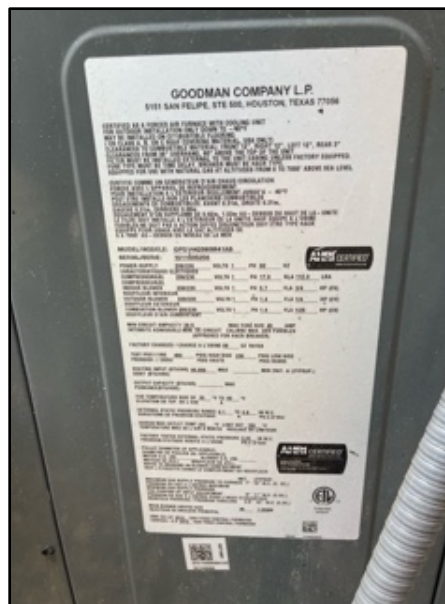
## Comment 49:

The gas pack heating and cooling system was manufactured in 2016. The system responded properly when tested in heating mode. The typical lifespan of a heating and cooling system is 15-20 years.

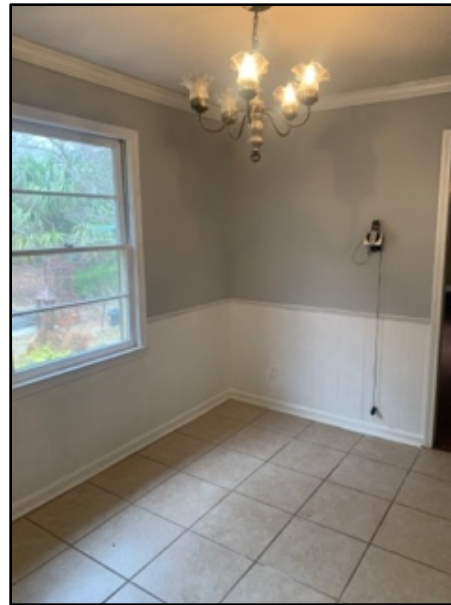
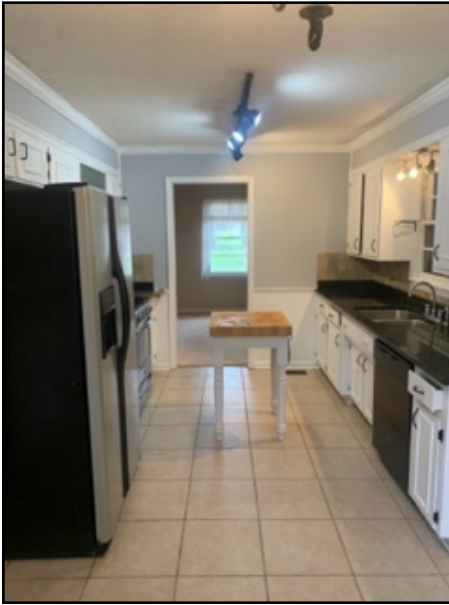
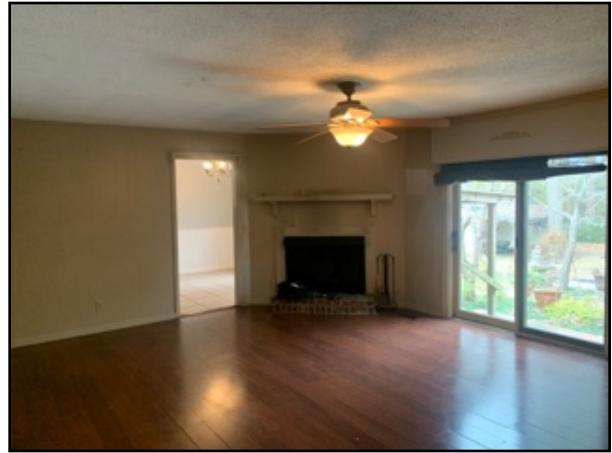
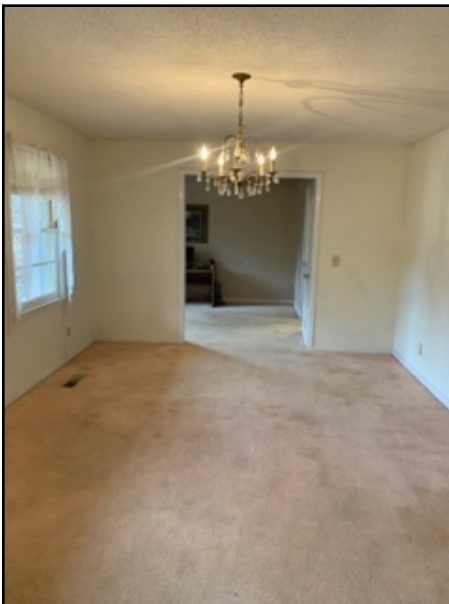
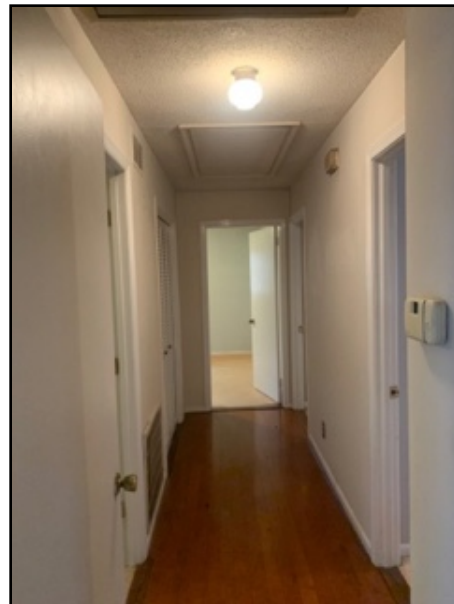
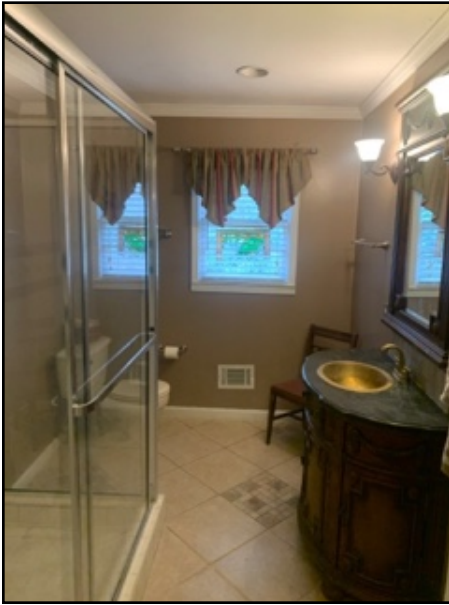
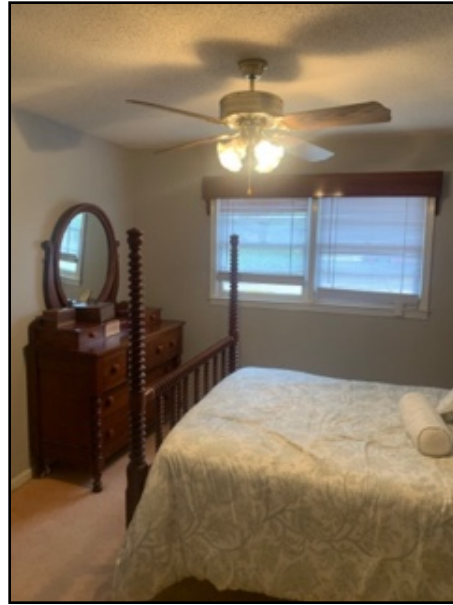
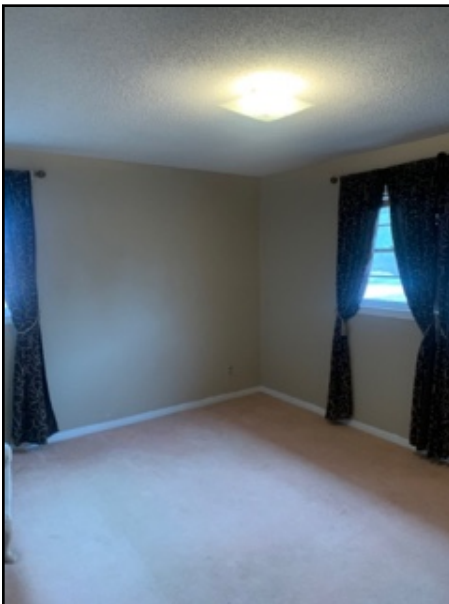
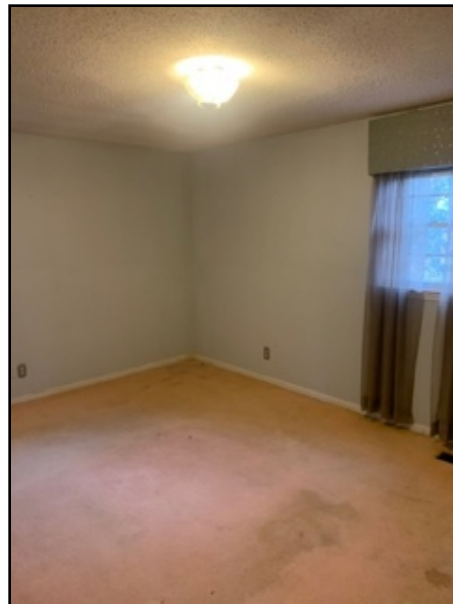
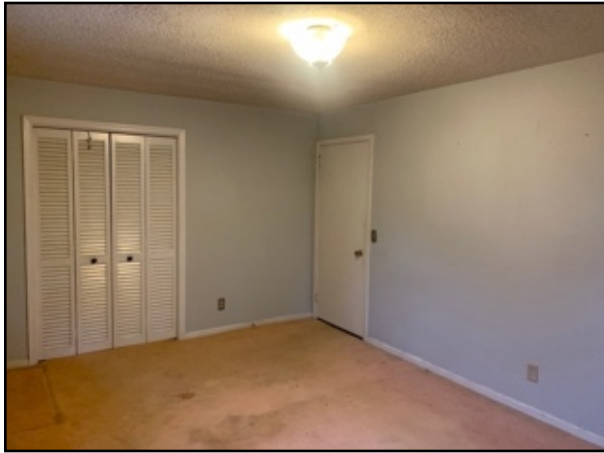
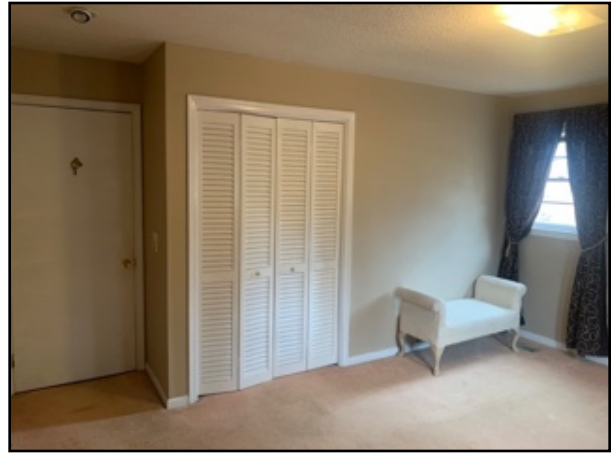
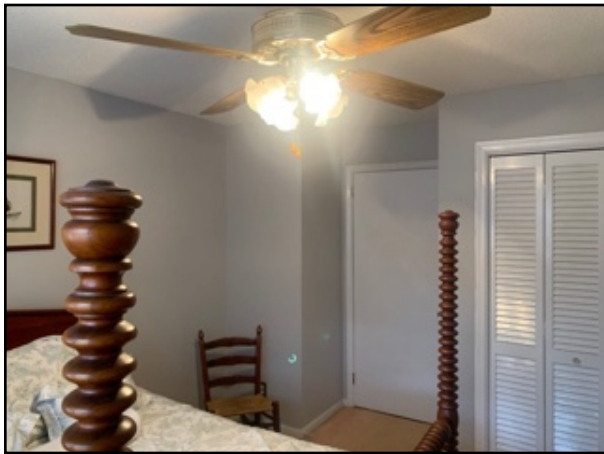
At the time of the inspection, no significant deficiencies were observed in the condition of the interior walls and ceilings. Inspection of the walls and ceilings typically includes examination for functional defects in the wall and ceiling coverings, window and door casings, baseboards and other installed moldings. Cosmetic defects are not noted except where a functional defect is present.

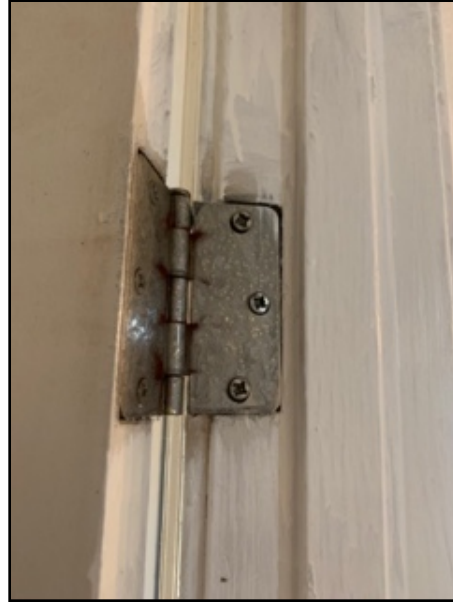
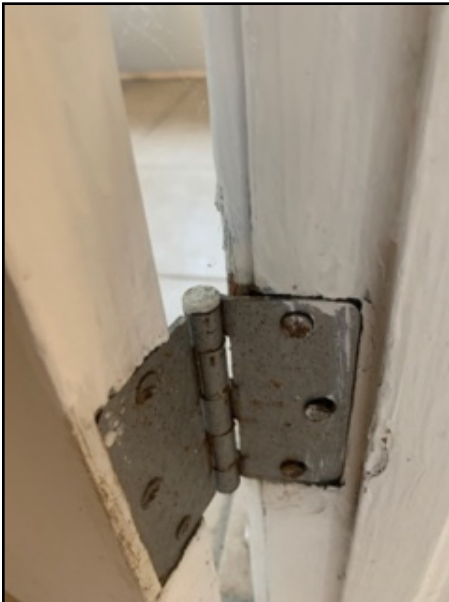
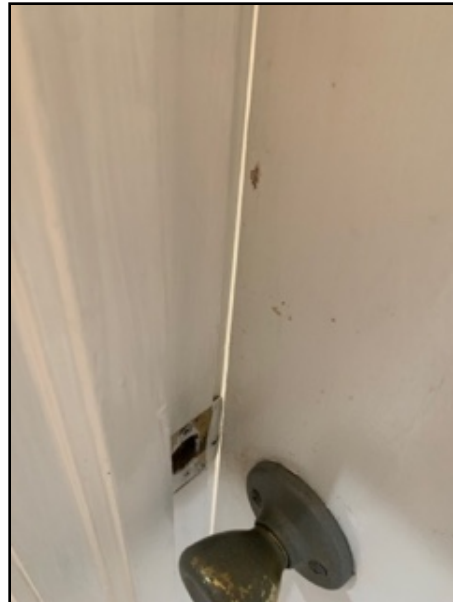
Loose door hinges on the laundry room door. Repair is recommended by a licensed contractor.

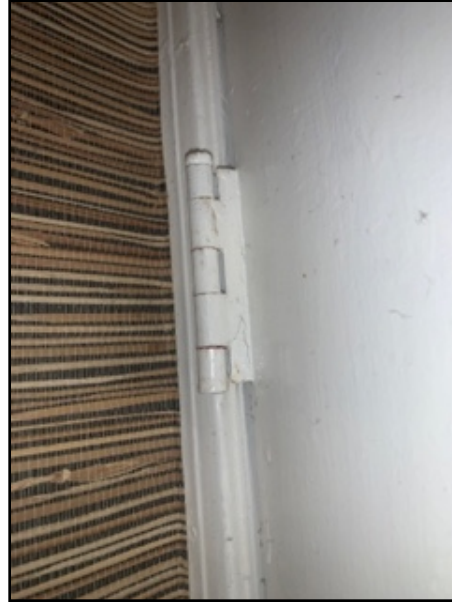
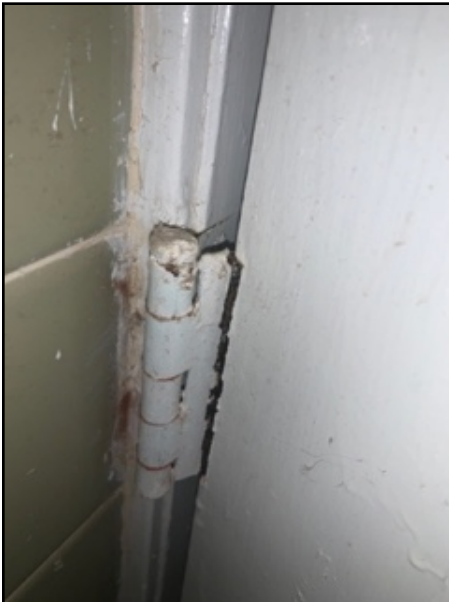
The master bathroom closet door does not close. The door hinges have been painted. Repair is recommended by a licensed contractor.

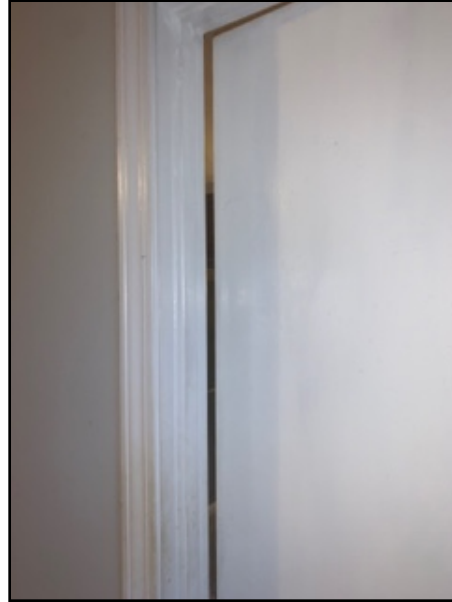
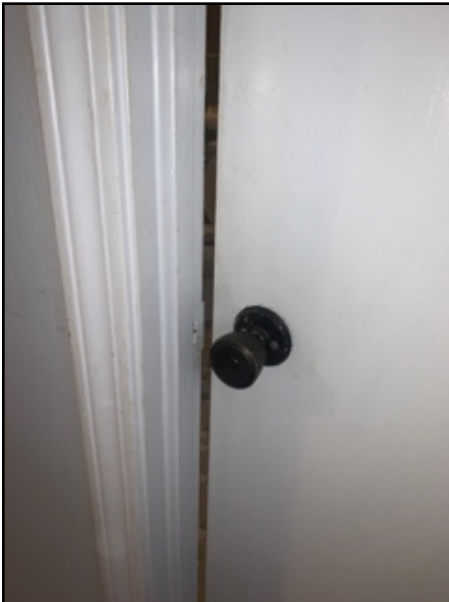
The master bathroom door does not close. Repair is recommended by a licensed contractor.

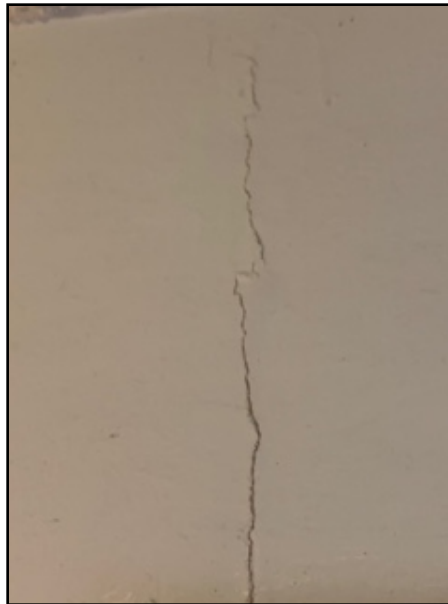
Figure 56-2

**Comment 56:**  
Cracking observed over the master bathroom doorway. Inspect and repair is recommended by a licensed contractor.

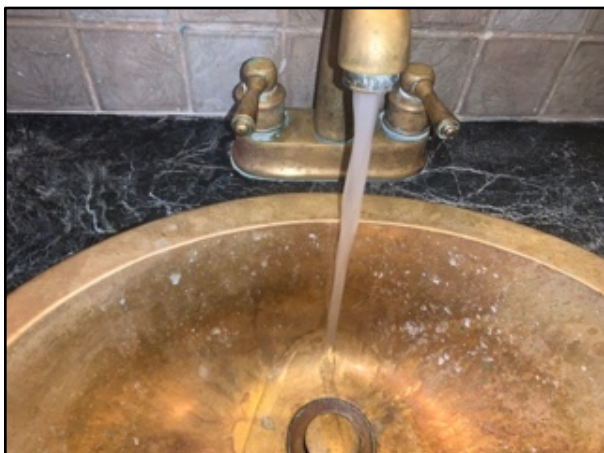
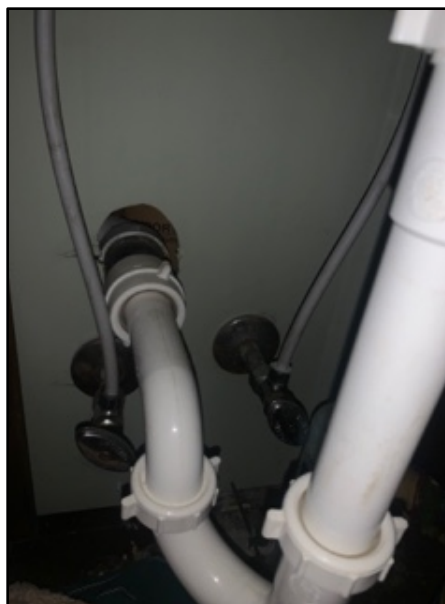
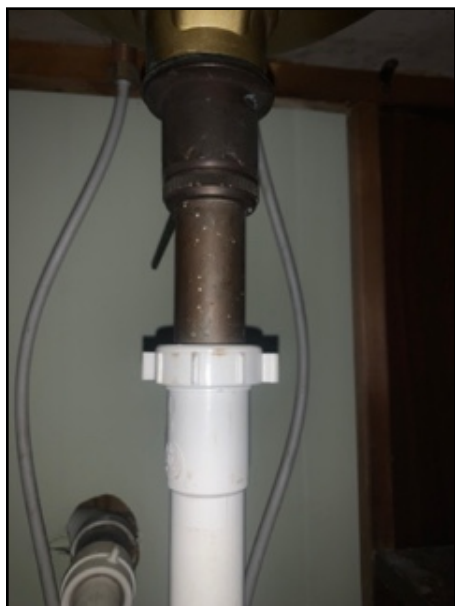
At the time of the inspection, no significant deficiencies were observed in the condition of the vanity and sink components. Inspection of the vanity and sink includes testing of the functional flow, functional drainage and operation of faucet.

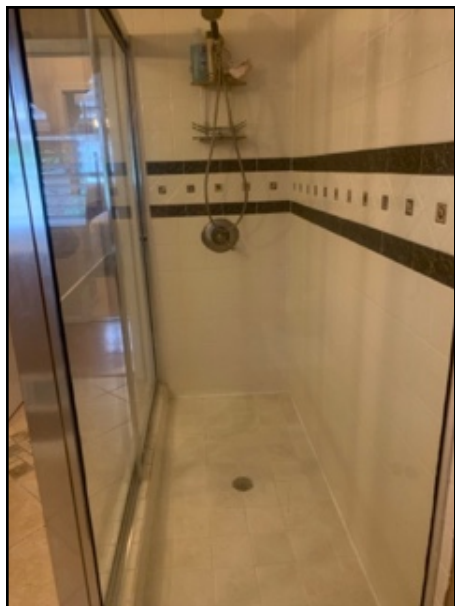
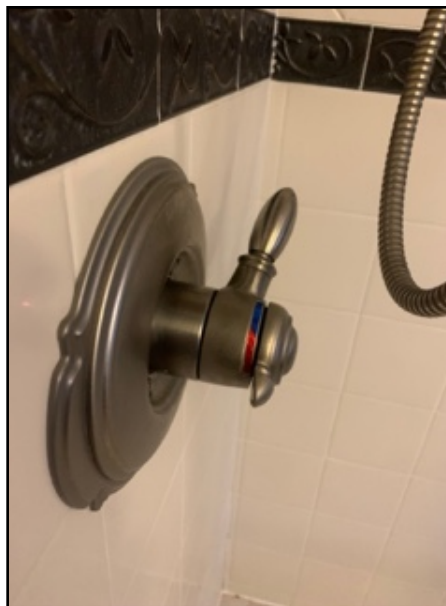
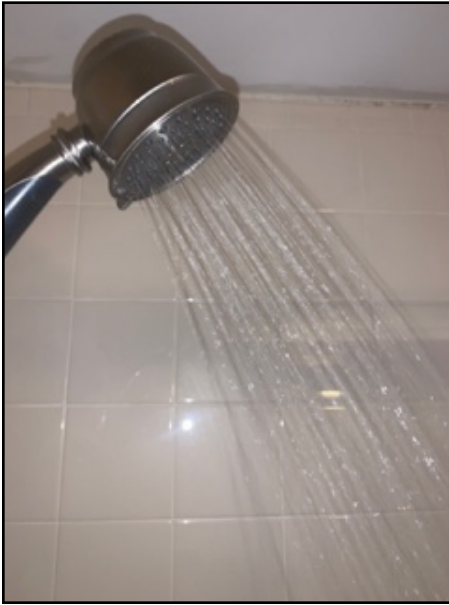
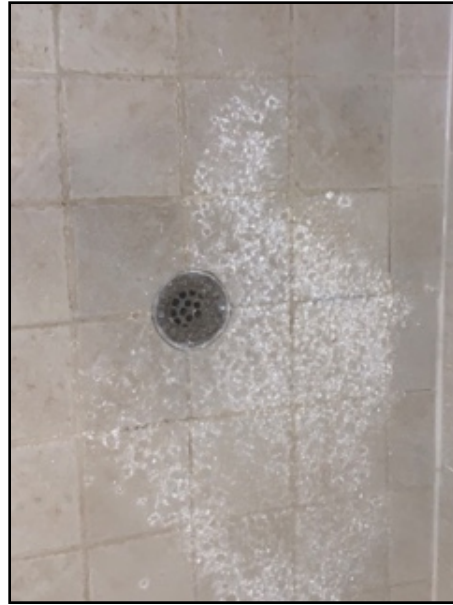
All shower components appeared to be in serviceable condition at the time of the inspection. Inspection of the shower typically includes evaluation of functional flow, functional drainage, operation of the faucet, diverter valves, and moisture intrusion around walls and base.

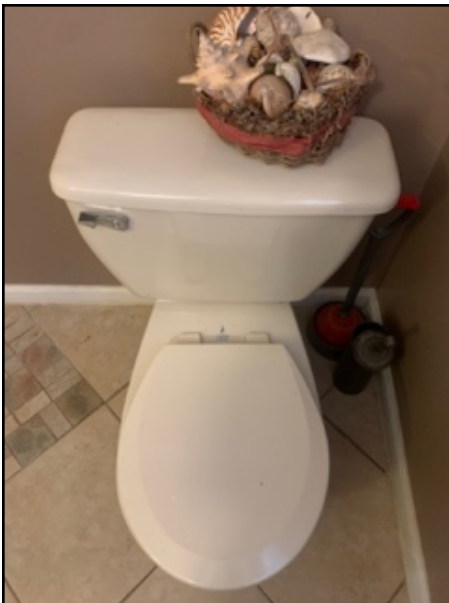
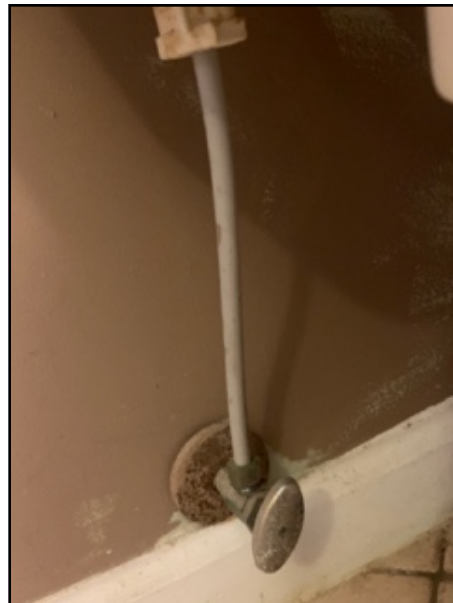
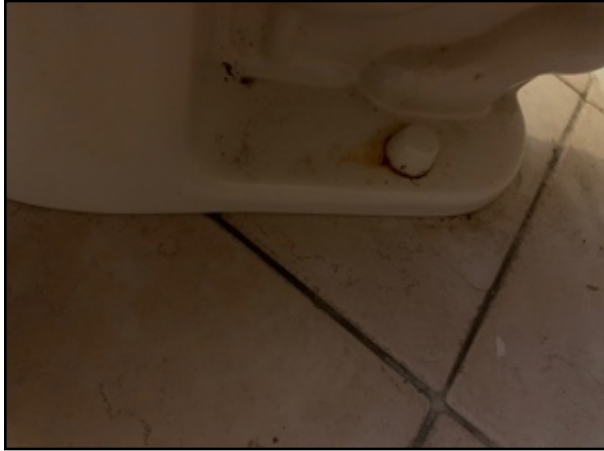
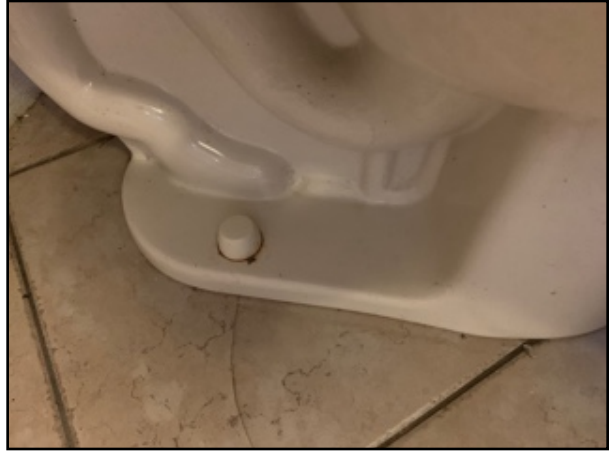
No deficiencies were observed to the toilet fixture. All toilet components operated in a manner consistent with their intended use.

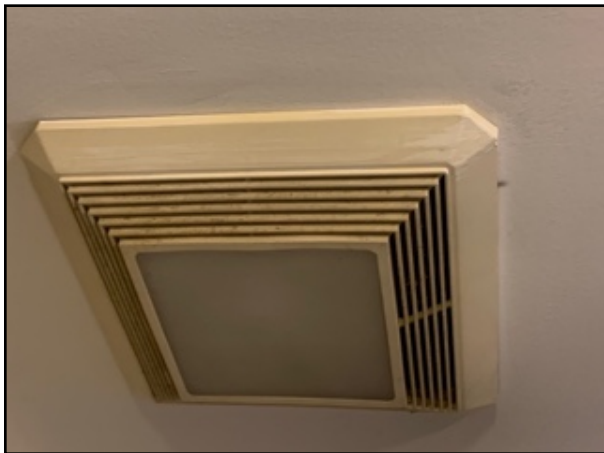
Figure 61-1

At the time of the inspection, an operable source of ventilation was present in the bathroom.

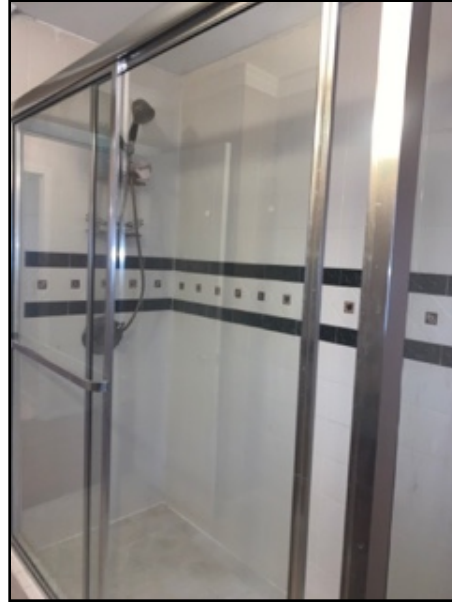
Figure 62-2

One of the shower doors is off the track. Repair is recommended by a licensed contractor.

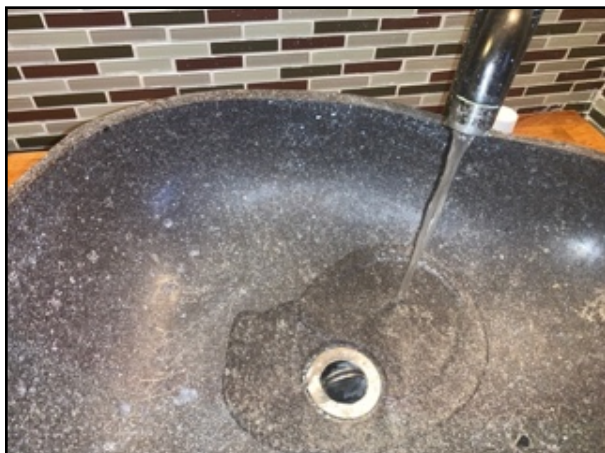
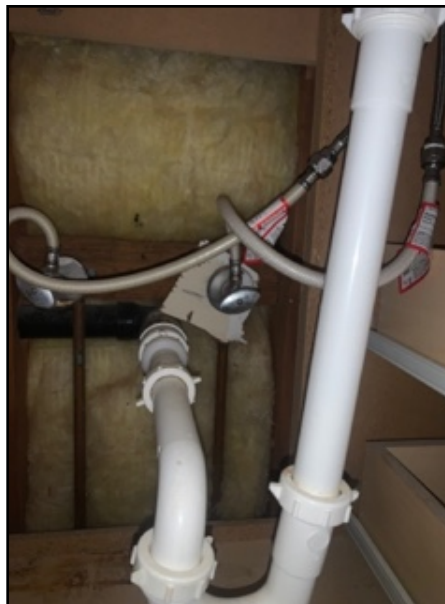
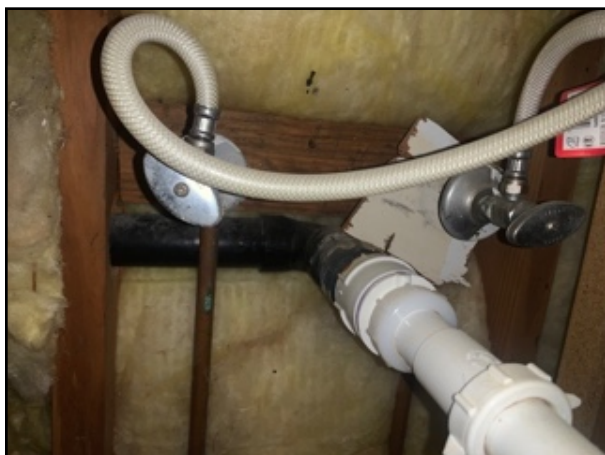
At the time of the inspection, no significant deficiencies were observed in the condition of the vanity and sink components. Inspection of the vanity and sink includes testing of the functional flow, functional drainage and operation of faucet.

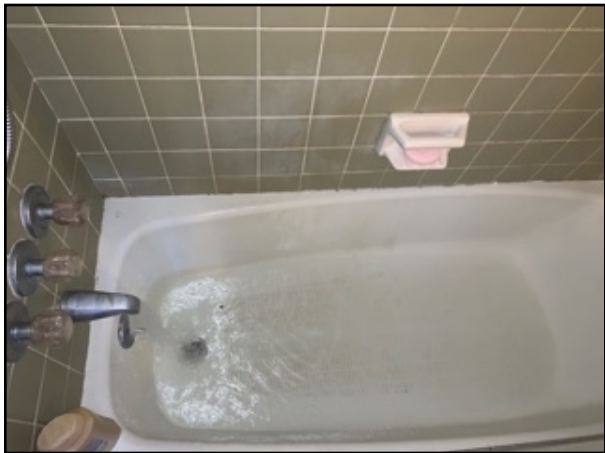
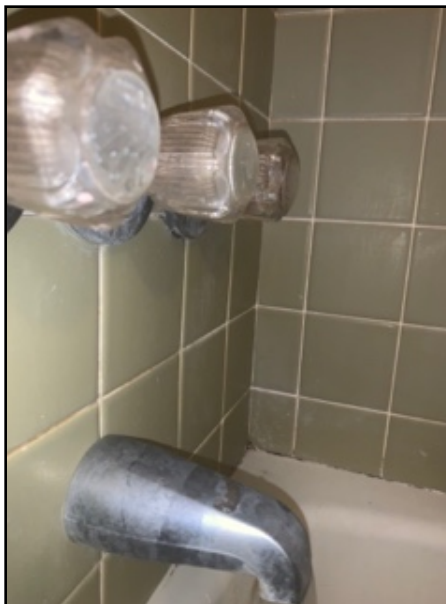
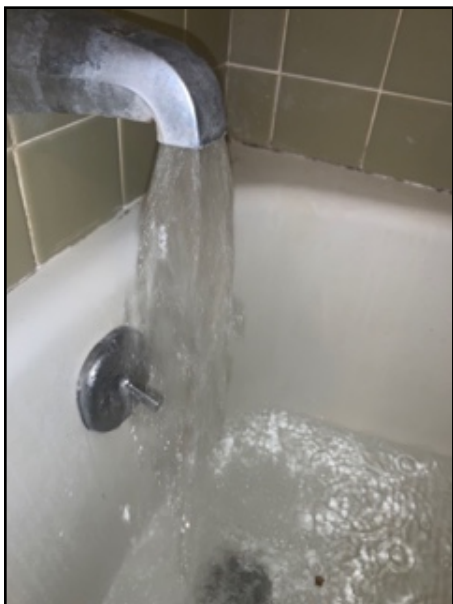
At the time of the inspection, no deficiencies were observed in the condition of the bathtub components. Inspection of the bathtub includes testing of the functional flow, functional drainage and operation of faucet and diverter valve.

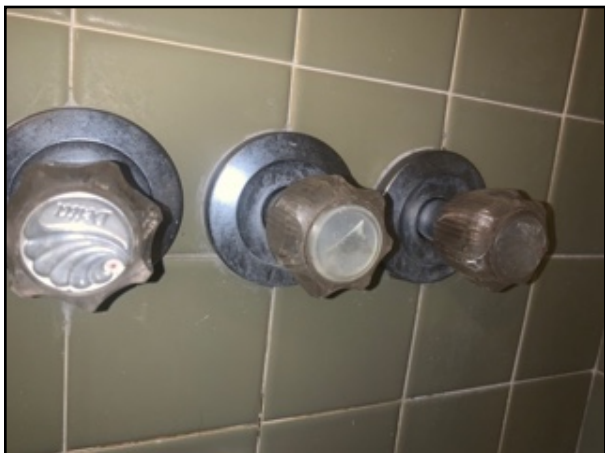
Figure 65-1

All shower components appeared to be in serviceable condition at the time of the inspection. Inspection of the shower typically includes evaluation of functional flow, functional drainage, operation of the faucet, diverter valves, and moisture intrusion around walls and base.

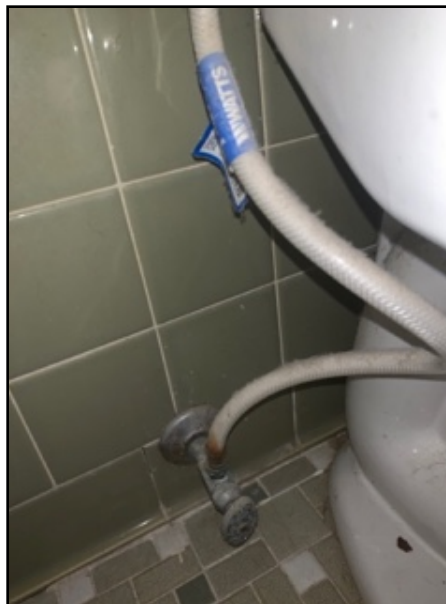
Figure 66-2

The toilet is loose at floor. The toilet seal needs to be replaced and firmly secured to the floor. Caulking the base is recommended. Repair is recommended by a licensed plumber.
