## Patriot Home Inspections

## Home Inspection Report

123 Any Street

Inspected on Wed, Feb 23 2022 at 6:07 PM

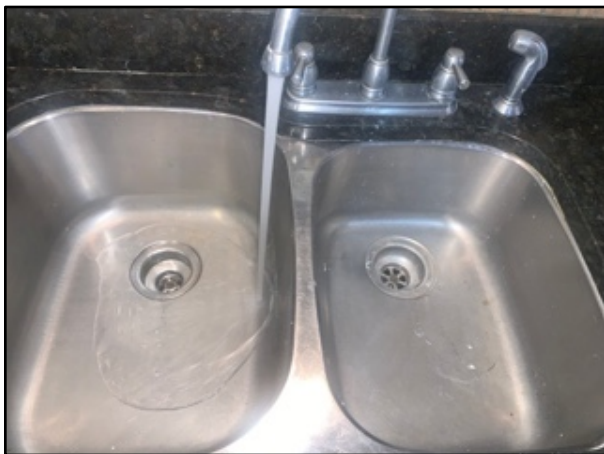
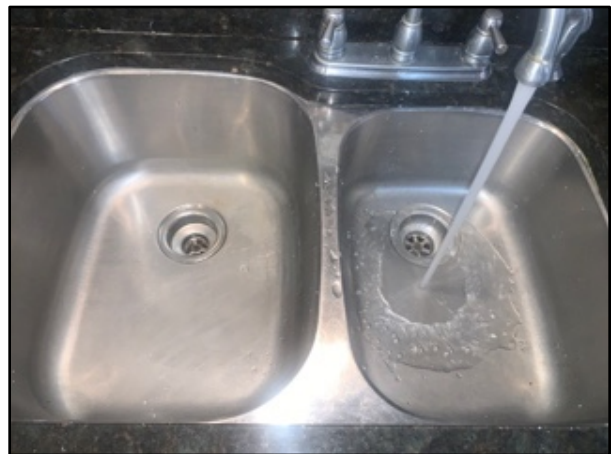
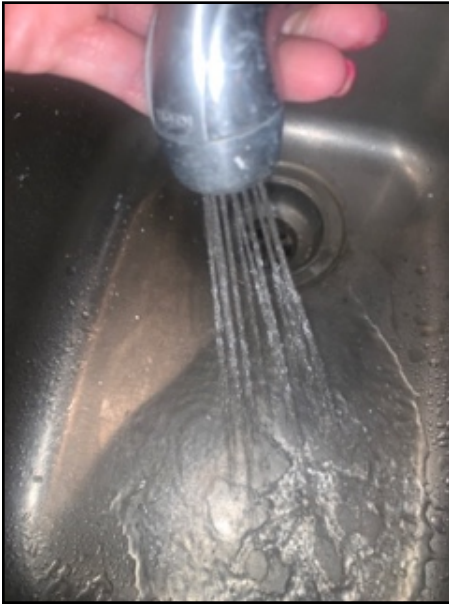
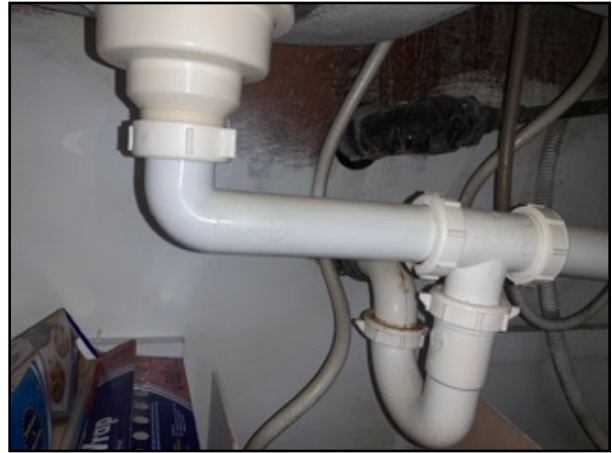
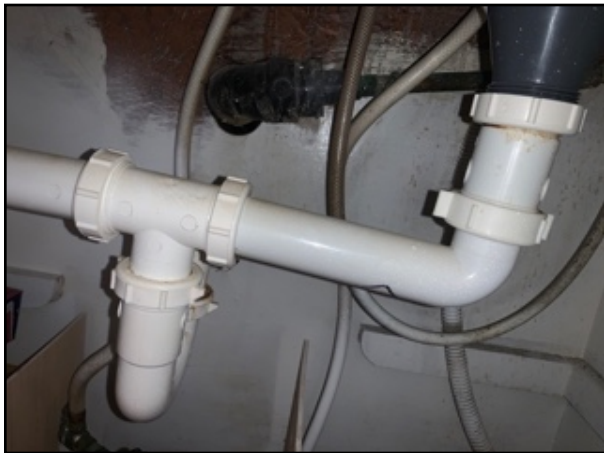
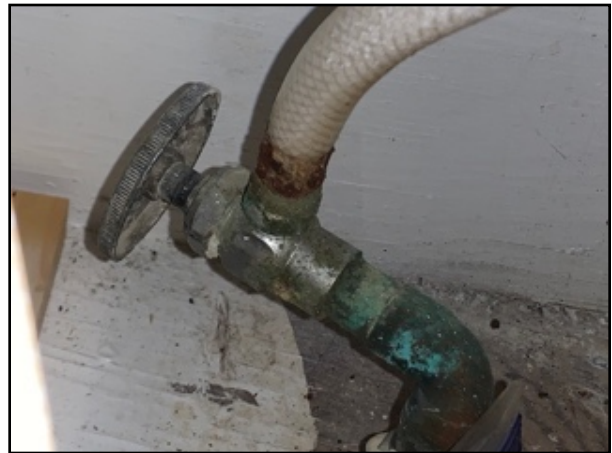
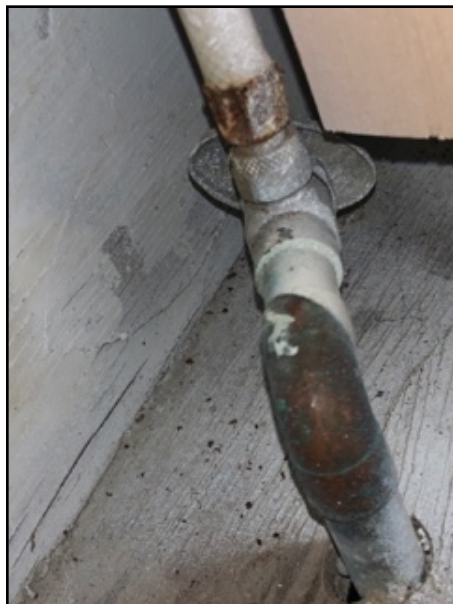
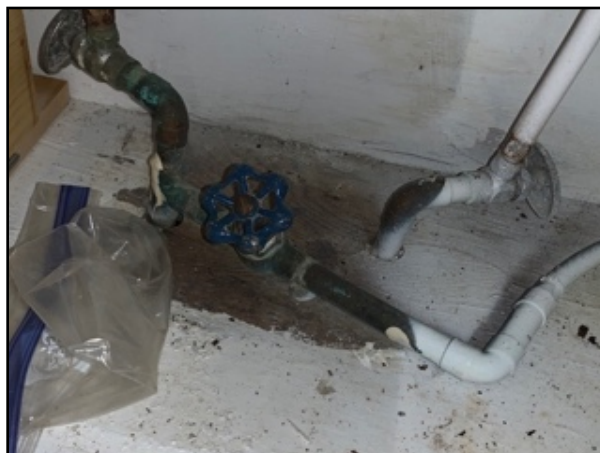
At the time of the inspection, the kitchen cabinets and countertops are in generally good condition. No major defects were observed to the cabinetry, countertops, sinks, faucets, or flooring. Cosmetic defects are not noted except where a functional defect is present.

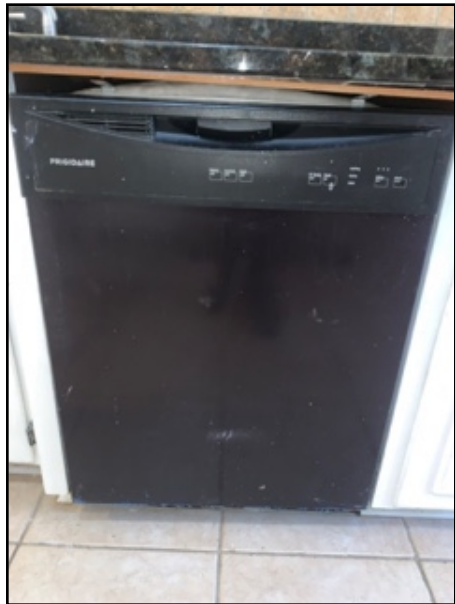
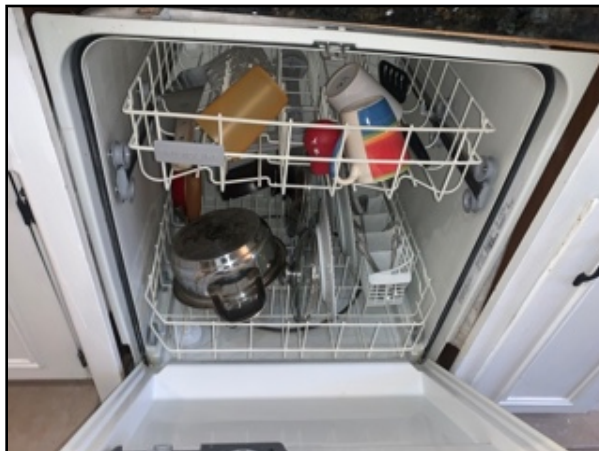
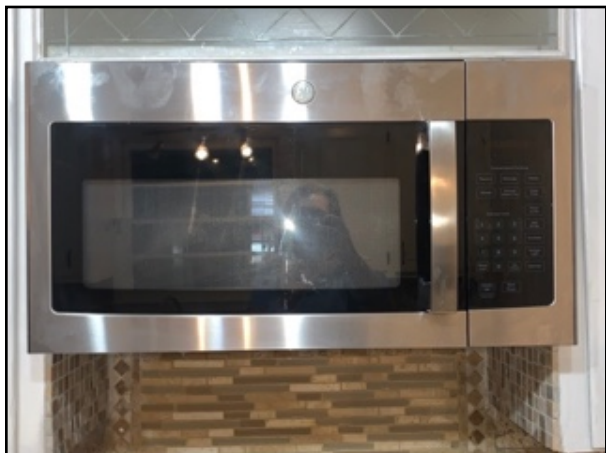
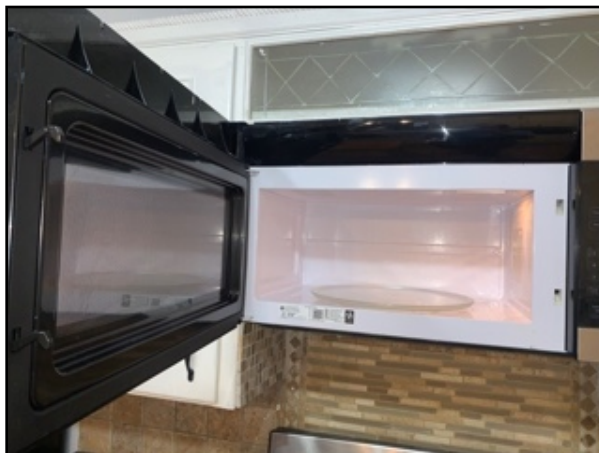
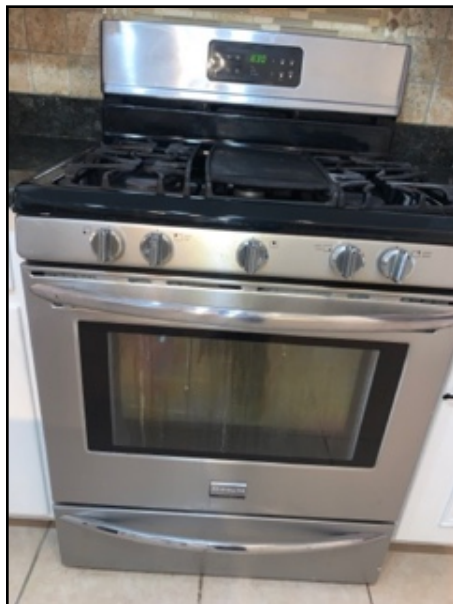
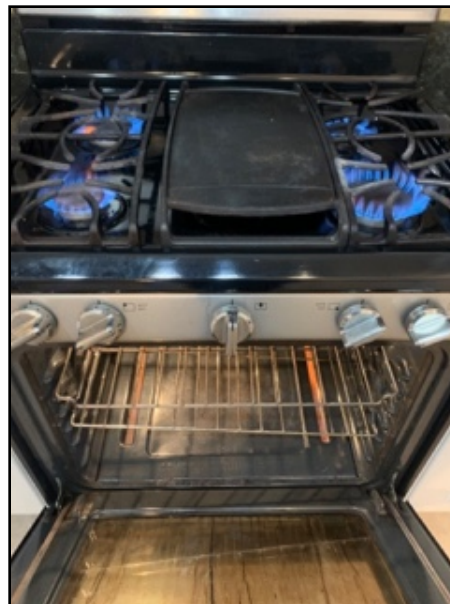
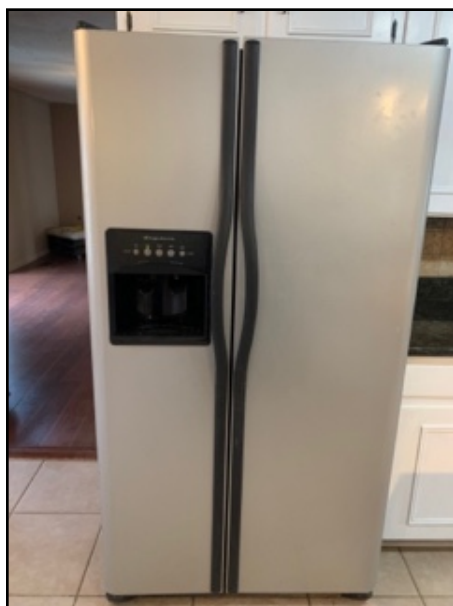
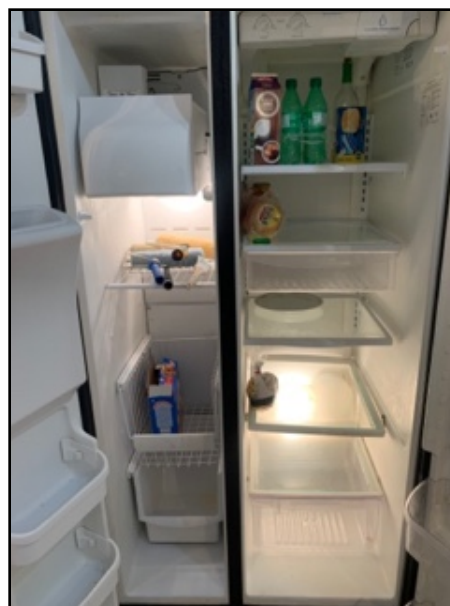
At the time of inspection, the appliances responded properly when tested. The appliances should have several years of useful life remaining.

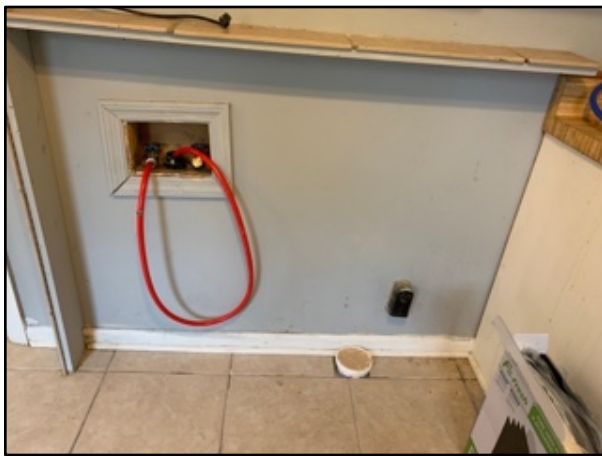
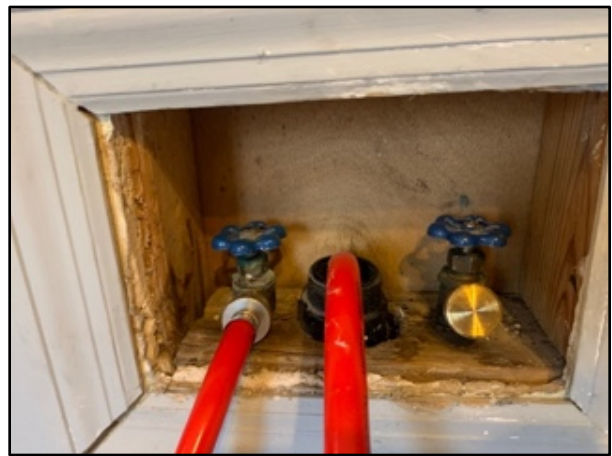
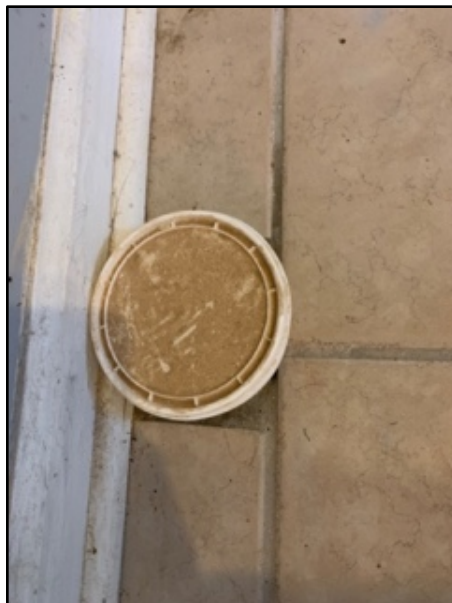
At the time of the inspection, no significant deficiencies were observed in the laundry room. The clothes washer connections and drain piping were visually inspected only.
